# Wildfire Research

## Ignition Potential of Decks Subjected to an Ember Exposure

Stephen L. Quarles, Ph.D.

Updated MAY 2018

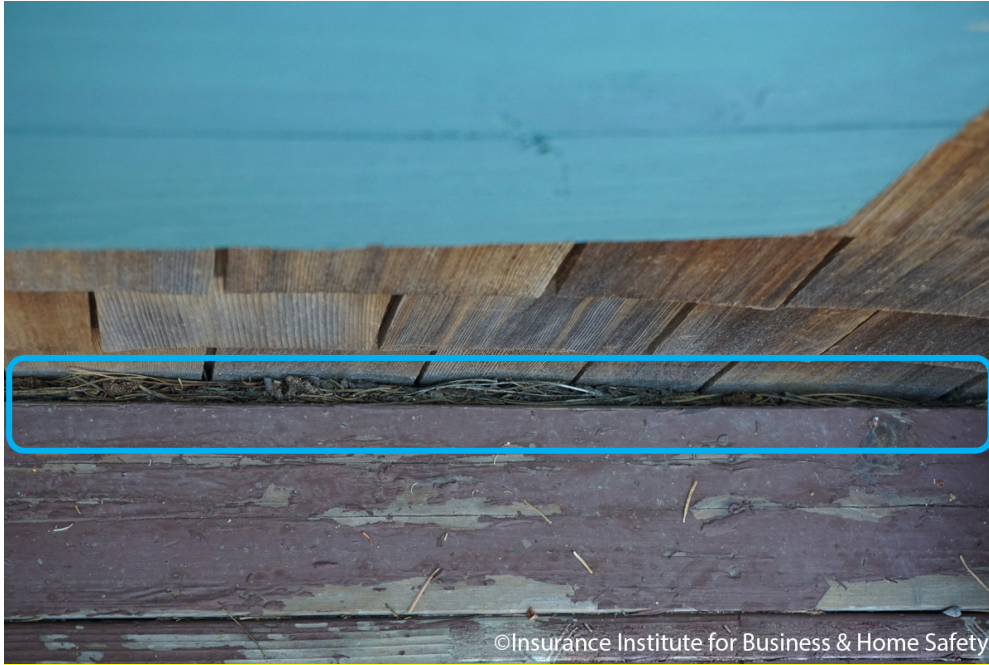
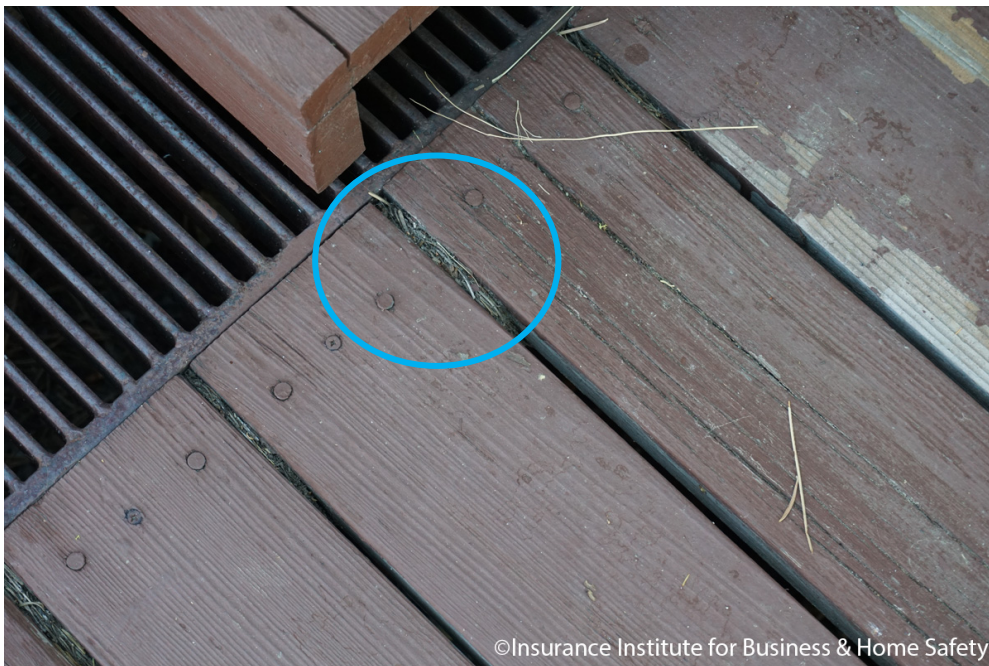
Figure 2. Typical debris accumulation points at deck-to-wall connection (top) and gap between deck boards (bottom).

Deck-to-wall connection details that result in a gap can allow for debris to accumulate. Debris can also accumulate in gaps between deck boards (refer to Figure 2). These gaps are intended to allow for expansion and contraction of deck boards and minimize the occurrence of unwanted buckling. When a building is threatened by wildfire, the deck will experience and must be able to resist an ember exposure. Ember accumulation in gaps could result in ignition of the debris and deck boards. Deck-to-wall design features,

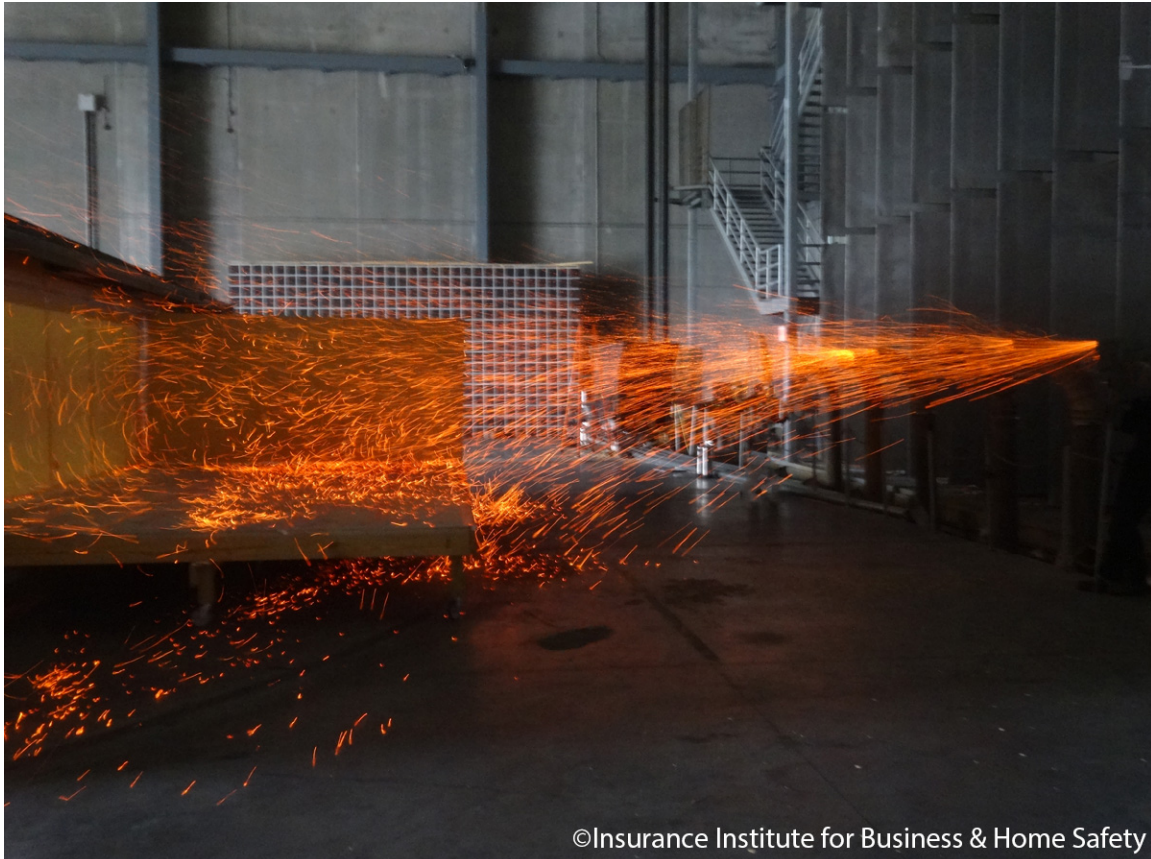
*Figure 6. Test deck exposed to embers from ember generators.*

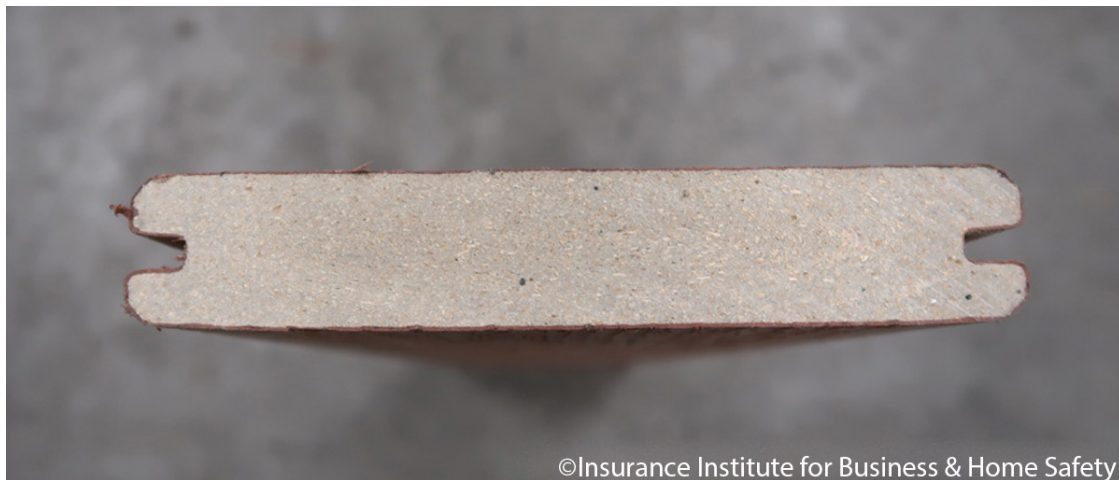
Figure 7. Example of a capped PC deck board. Note the reddish outer layer surrounding the lighter gray core material.

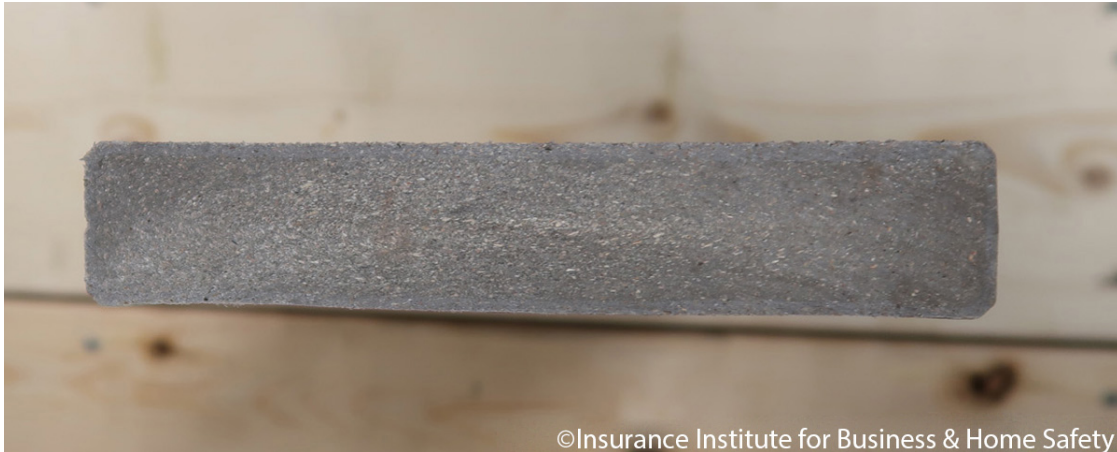
Figure 8. Example of a non-capped PC deck board.

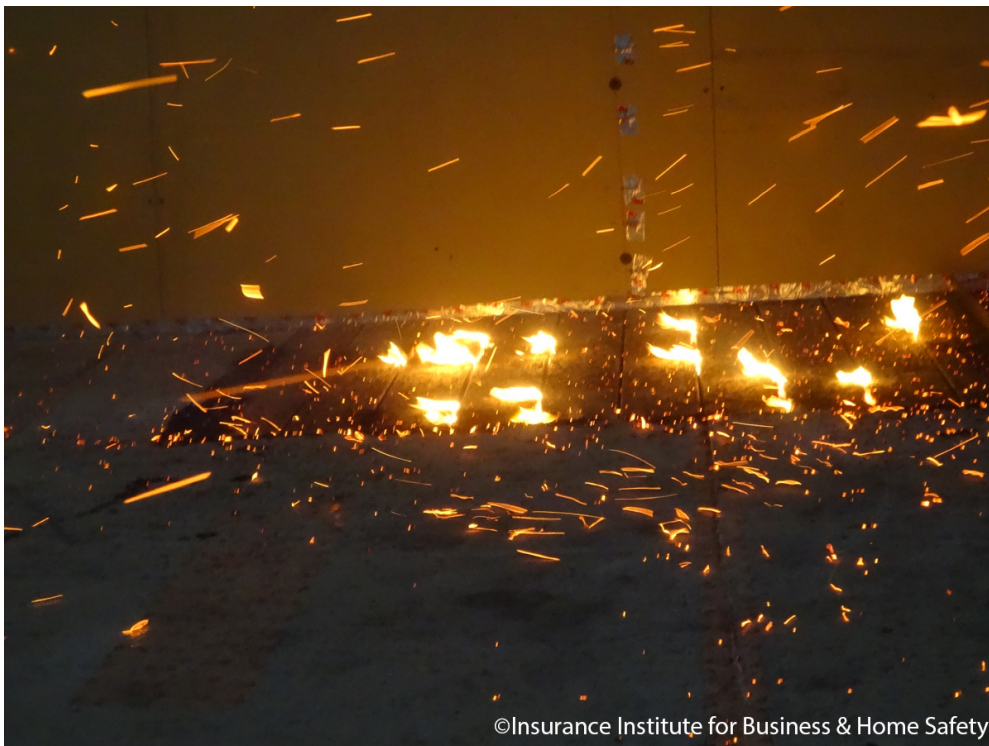
*Figure 13. Flame heights (never more than a few inches high) on ignited, medium-density softwood deck. Flaming was sustained when there was sufficient heat transfer between components (i.e., deck boards and joists), after which flaming ceased.*

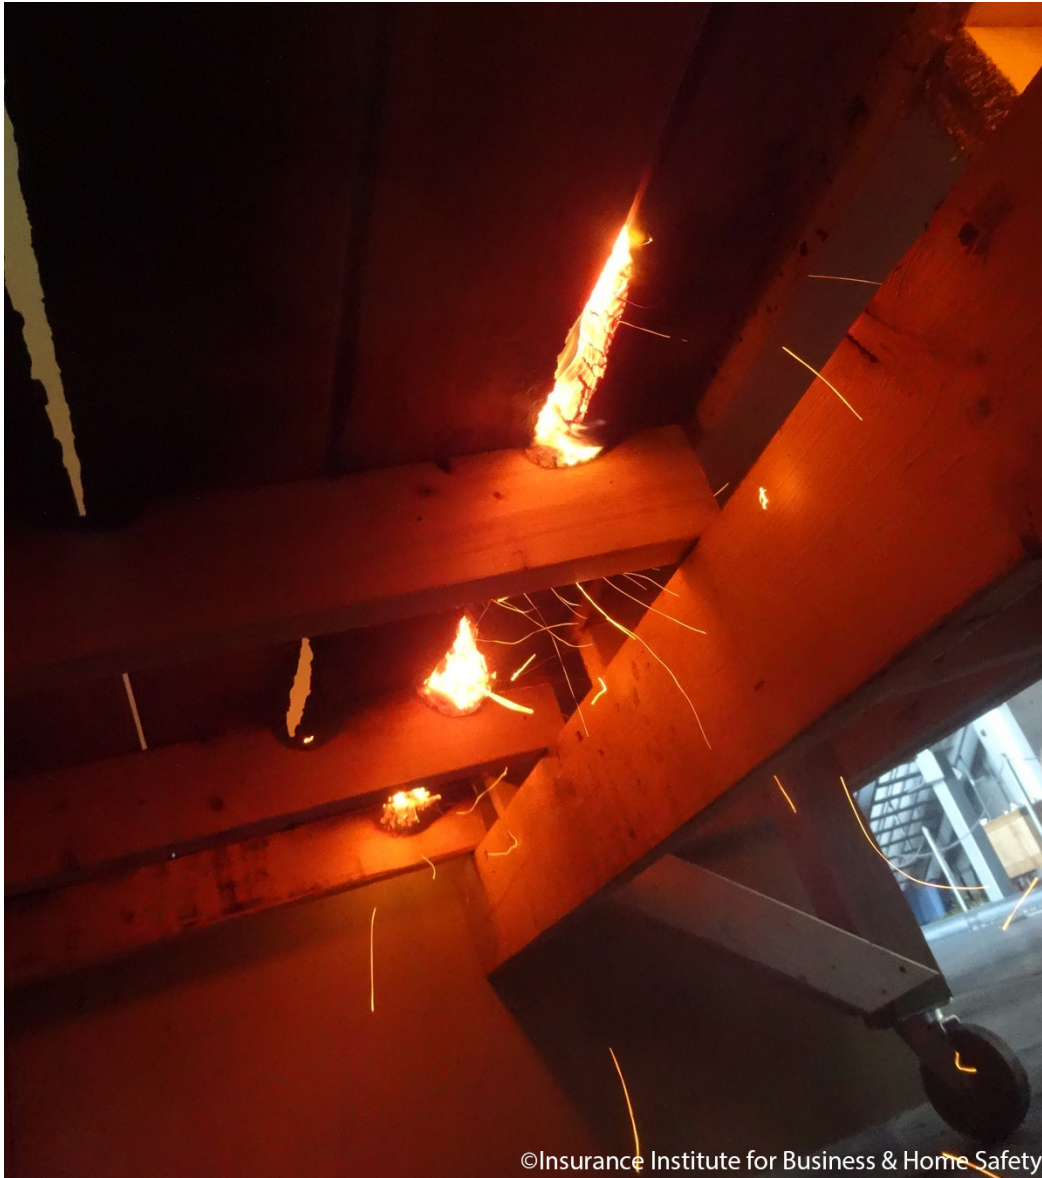
*Figure 14. View of underdeck area. Flaming transitioned back to glowing/smoldering when the gap between deck boards and joists reached a point where flaming could not be sustained by radiant heat transfer.*

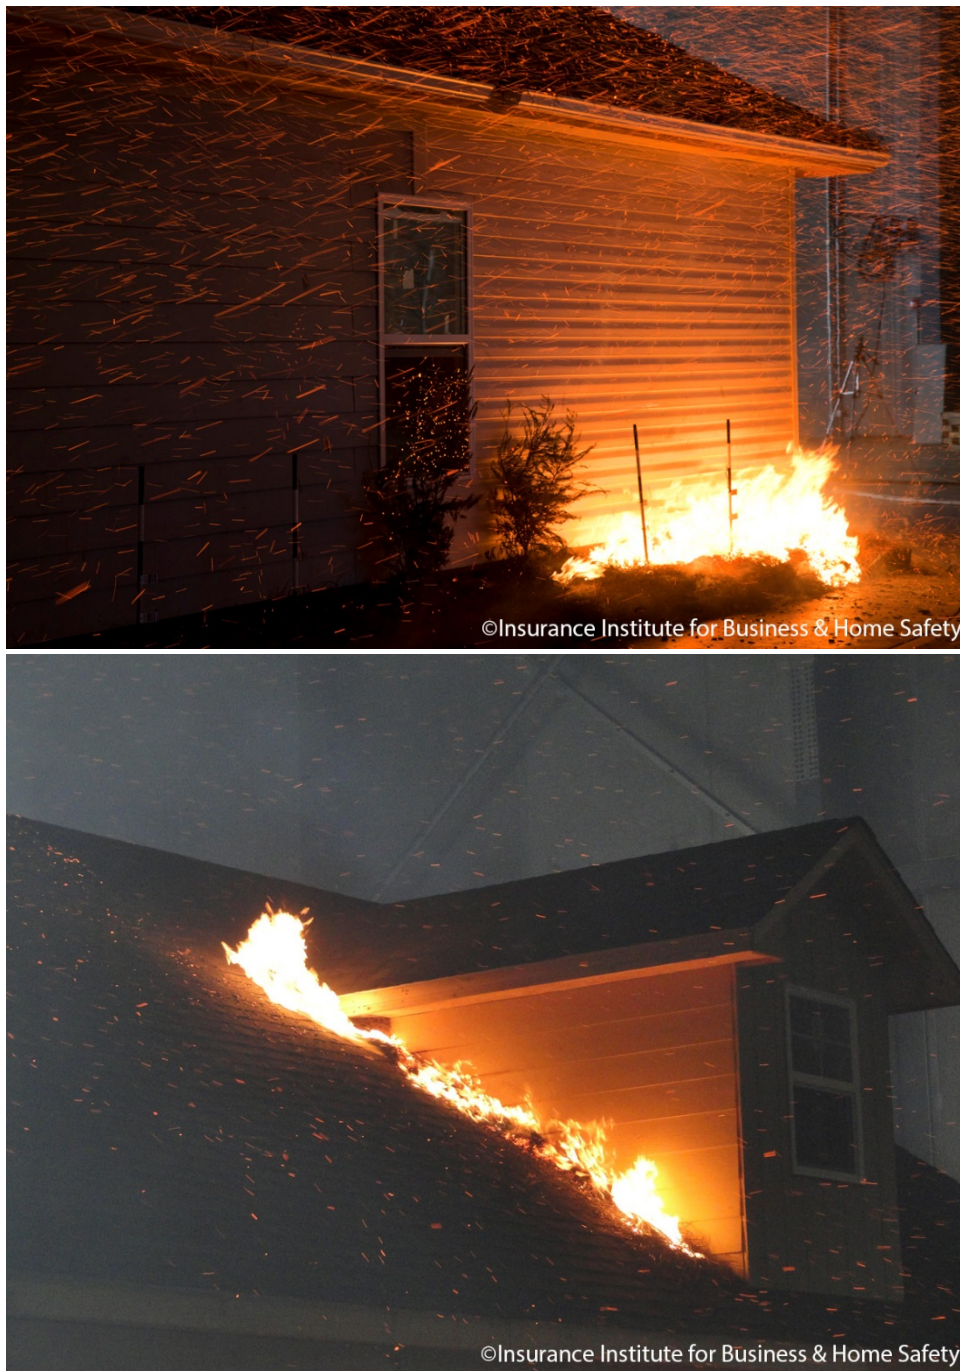
*Figure 15. Ember ignitions of pine needle mulch at the base of an exterior wall (top) and pine needle debris at a roof-to-wall intersection (bottom). Photos are from experiments conducted at the IBHS Research Center in 2011.*

Although not investigated in this series of experiments, the accumulation of vegetative debris at the deck-to-wall juncture and in gaps between deck boards would likely facilitate ignition and possibly the transition from smoldering or glowing to flaming. As shown in Figure 15, testing at the IBHS Research Center has consistently demonstrated that an ember exposure will result in the flaming ignition of bark and pine needle mulch products. The packing density of pine needles and other vegetative debris would likely be different in a deck board gap compared to a mulch product or accumulation on a roof, which would affect ignition potential.

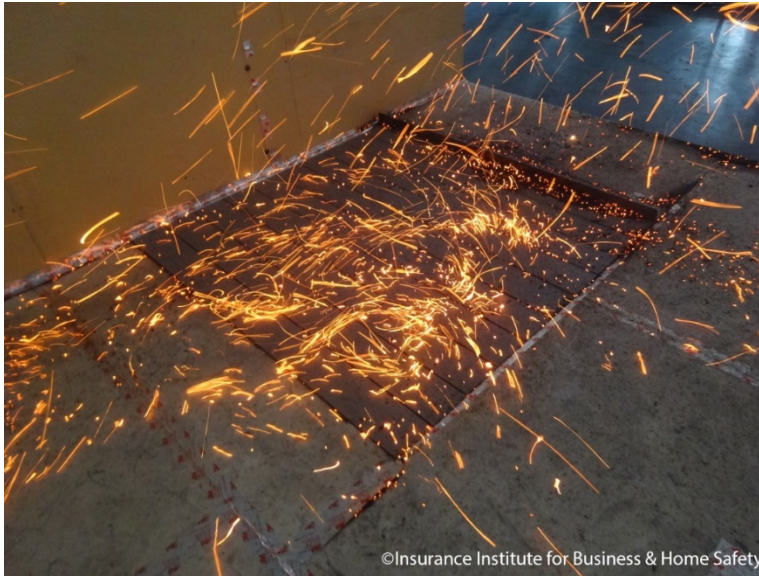
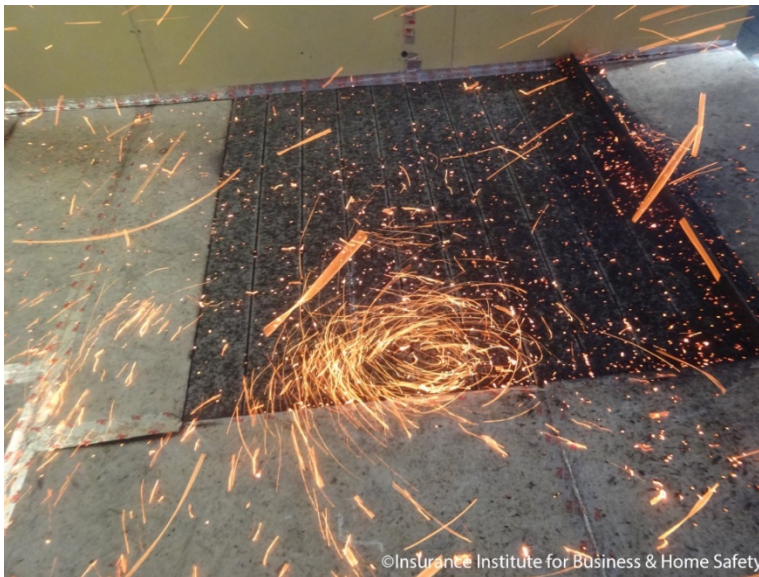
Figure 16. Ember accumulation areas on deck.

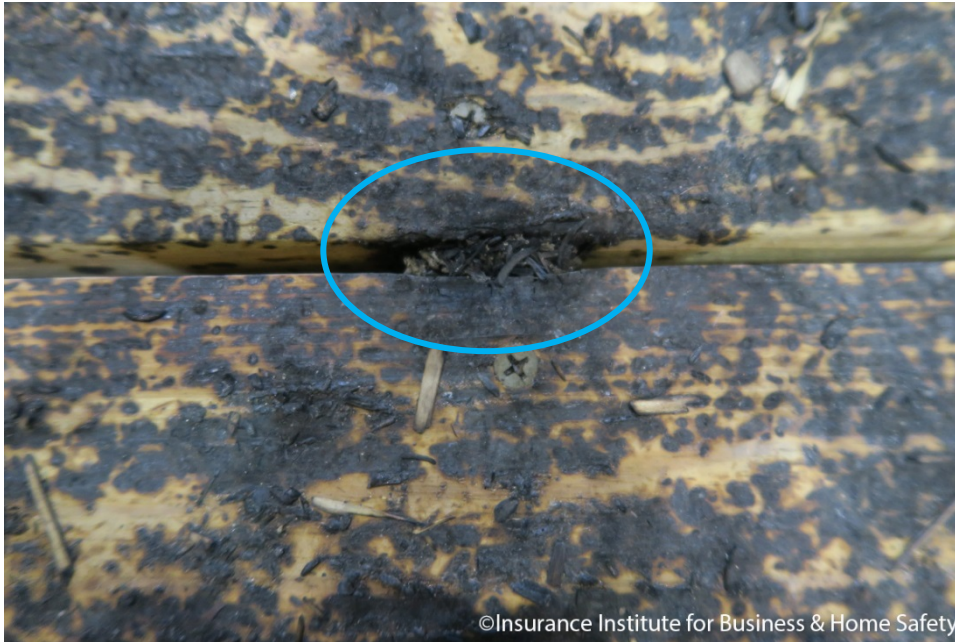
Figure 17. Ember accumulation in gap between deck board above a support joist.

top of the joist (Figure 17). Flaming and smoldering ignitions consistently initiated in the gaps where deck boards crossed joists, or at the edge of the test decks where there was an underlying horizontal surface where embers could accumulate. Accumulation at these locations occurred regardless of deck board type. Small piles of embers also accumulated at some locations on the deck board surfaces. Accumulation always occurred on both sides of the metal bar and at deck perimeter locations where the test deck abutted the solid surface deck. Smoldering was often observed at these locations.

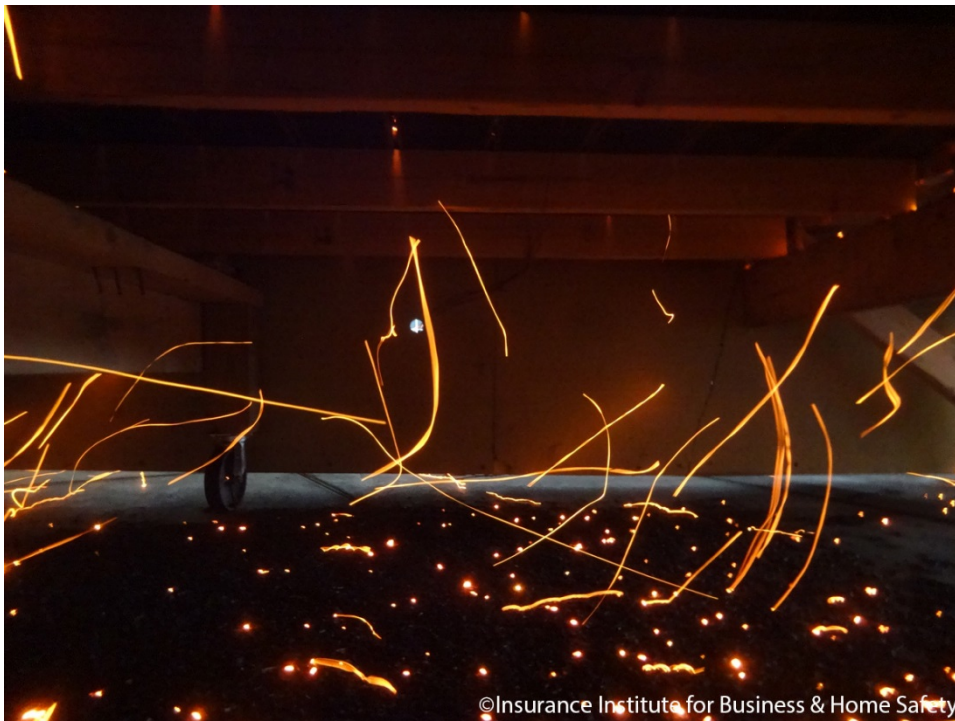
Figure 18. Ember penetration through gaps between deck boards and accumulating on the ground below.

In non-joint locations, embers dropped into and through the gap, onto the surface below (Figure 18).

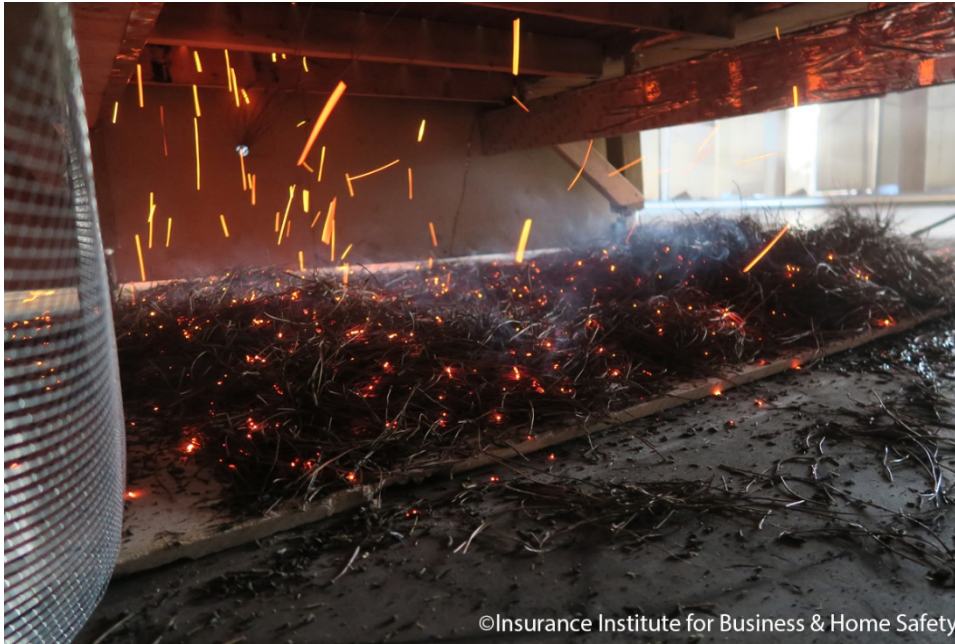
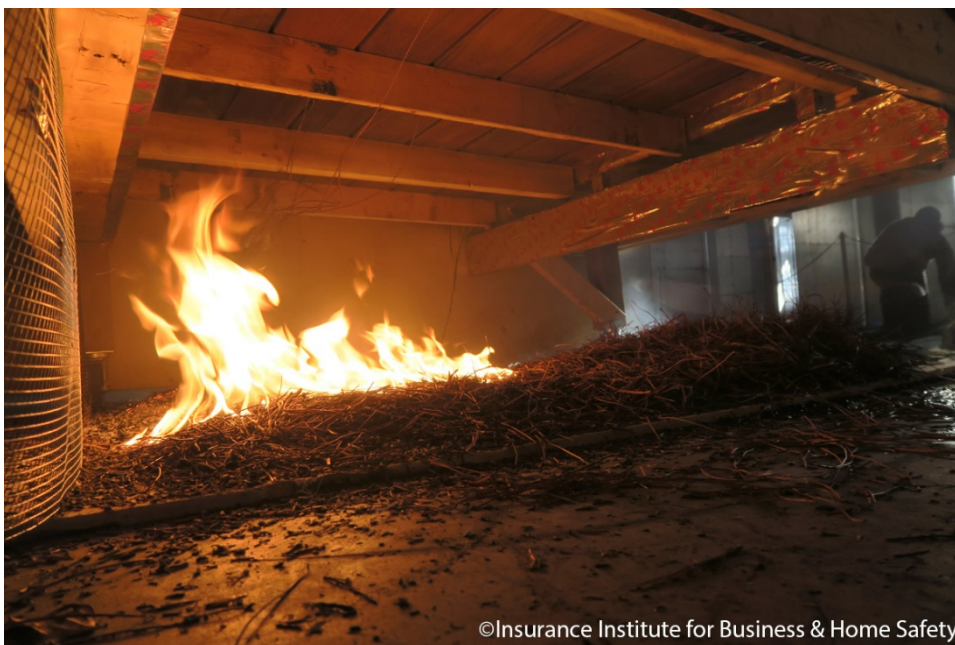
*Figure 19. Ember penetration through gaps between deck boards; embers falling to ground (top) and resulting in the ignition of pine needles under deck (bottom).*

Embers falling through gaps between deck boards could ignite fine combustible fuel beneath the deck. To demonstrate this potential, a test was conducted that

incorporated pine needle debris below the deck (refer to Figure 19). As was the case for other experiments, this test was run using the medium wind-speed record. The ember exposure resulted in smoldering combustion for most of the ember exposure period. Smoldering transitioned to flaming when the wind speed was lowered to the idle condition. The ignition of the fine fuels from embers that fell through the gaps between deck boards provides additional supporting evidence that storage of combustible materials under the deck should be avoided.

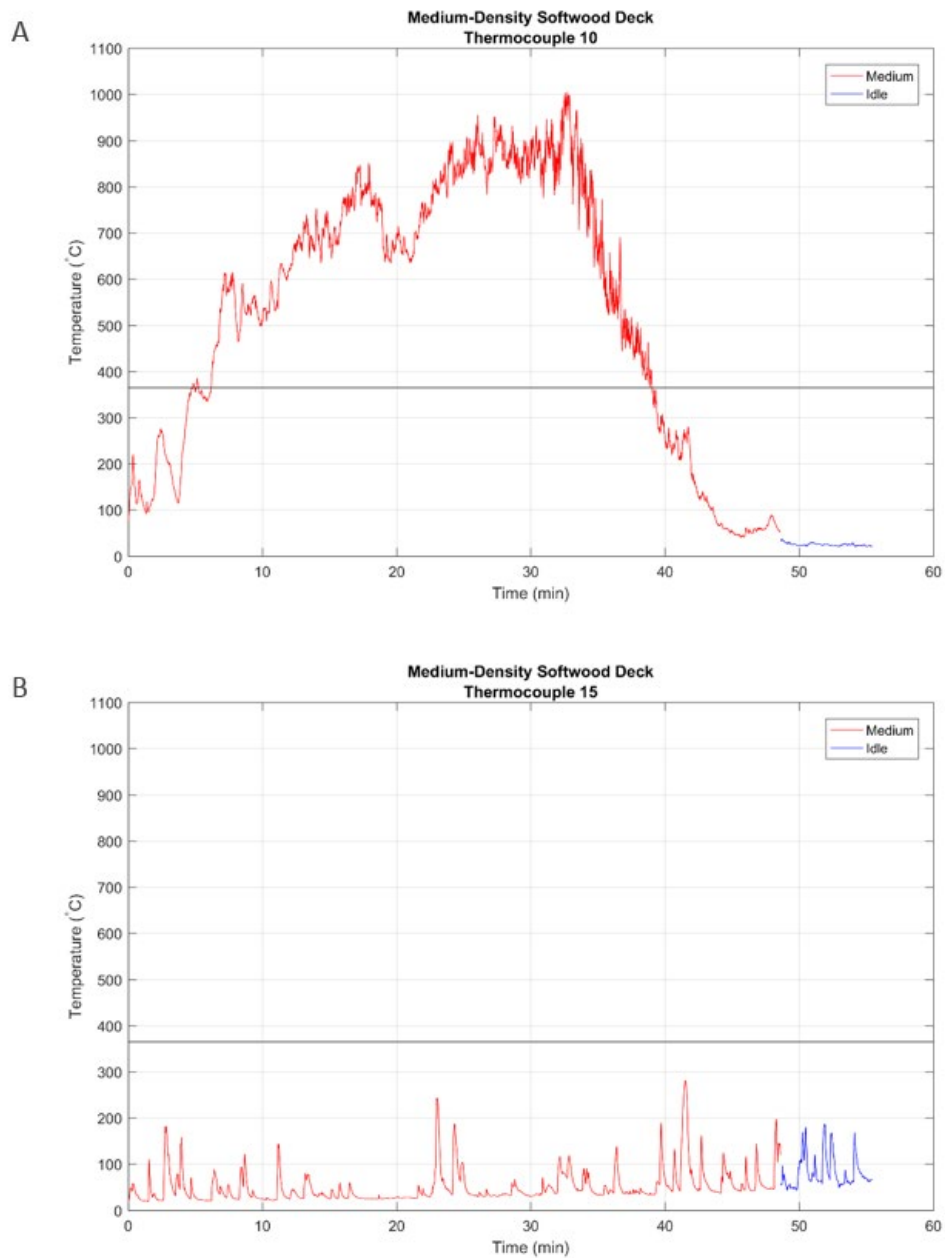
Figure 20. Temperature data collected for the medium-density softwood at a between-deck-board gap and joist crossing (A) and at a between-deck-board gap between joists (B). The approximate ignition temperature of wood is indicated by the horizontal black line (Janssens, 1991).

20. Data from a PE-1 deck is shown in Figure 21. For both products, temperatures were higher in the location where embers accumulated in a gap located over a joist. Flaming ignition was observed at this location on the softwood deck, but not on the PC deck. As indicated by the recorded temperatures, flaming ignition was not observed at the mid-joist locations (Figure 20-B and Figure 21-B) where embers fell through the gap and onto the ground. This supports the observations regarding conditions where flaming ignition occurred during these tests.

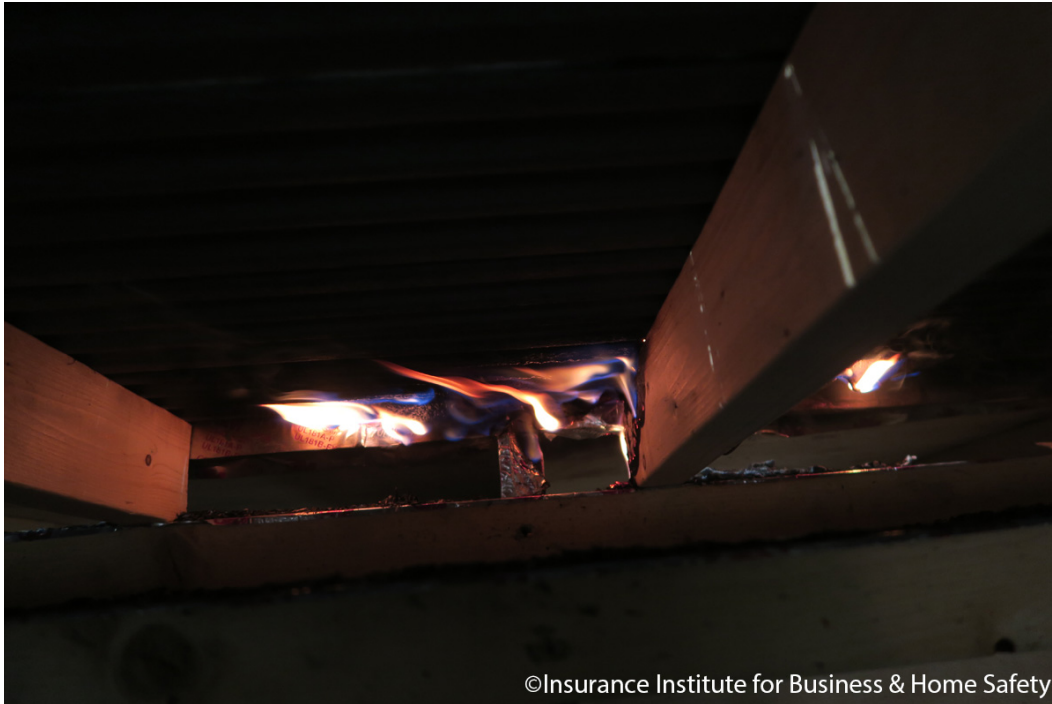
Figure 23. Flame spread in the underdeck area of PC product PE-1.

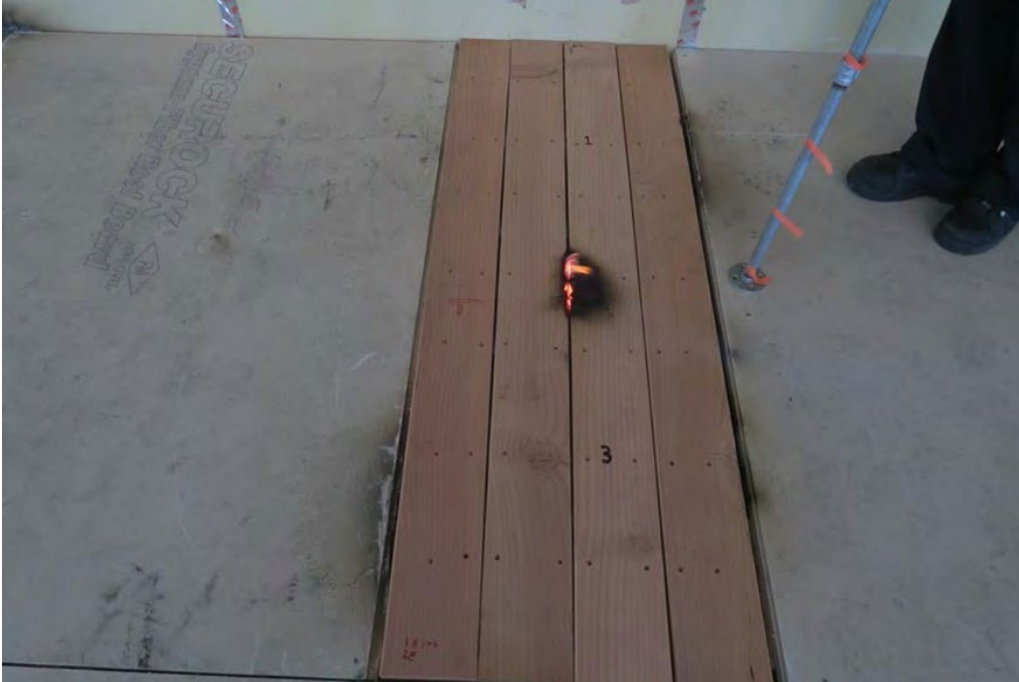
Figure 25. When deck boards were perpendicular to the building, fire spread toward the building occurred in the gap between deck boards.

Fire propagation occurred either in the gap between deck boards or in the interface between the top of a joist and bottom of a deck board (Figure 25 and Figure 26). This observed propagation occurred regardless of whether wind direction was parallel or perpendicular to the deck.

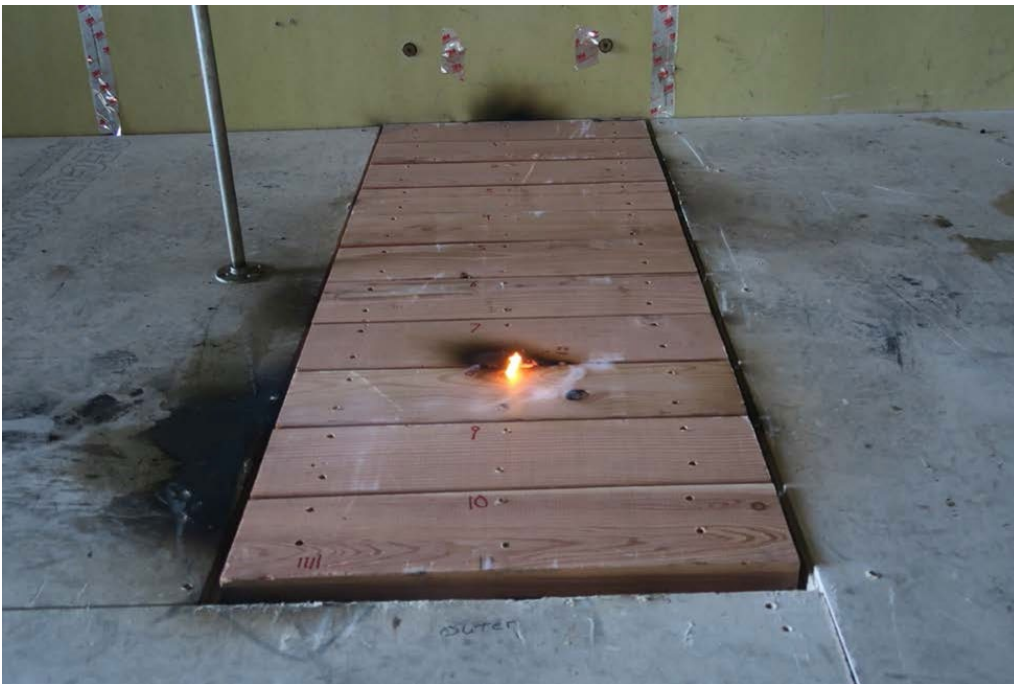
Figure 26. When deck boards were parallel to the building, fire would propagate laterally (parallel to the building) in the gap between deck boards, and toward the building at the interface between the bottom of the deck board and top of joist. Flaming combustion would occur when the fire reached a gap. Smoldering combustion would occur in the underdeck region when propagation was occurring in the interface between the top of a joist and bottom of a deck board.
