An examination of the Lytton, British Columbia wildland-urban fire destruction

Summary Report to the British Columbia FireSmart™ Committee

May 2022

ICLR research paper series – number 73

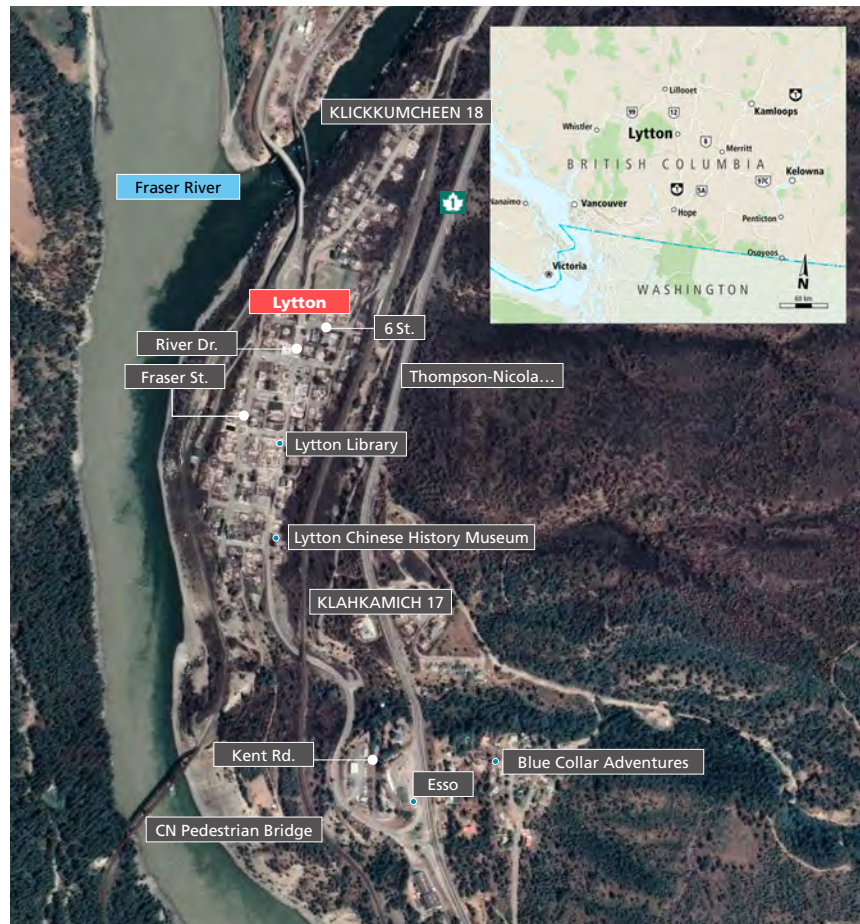
Figure 1: Lytton, British Columbia and the principal areas of examined community destruction.

Lytton, British Columbia (community population ~450 persons) is located about 260 km northeast of Vancouver (Fig. 1, inset). The community is situated on the east side of the steep sloped Fraser River Canyon, on a bench elevated above the confluence of the Thompson and Fraser Rivers.

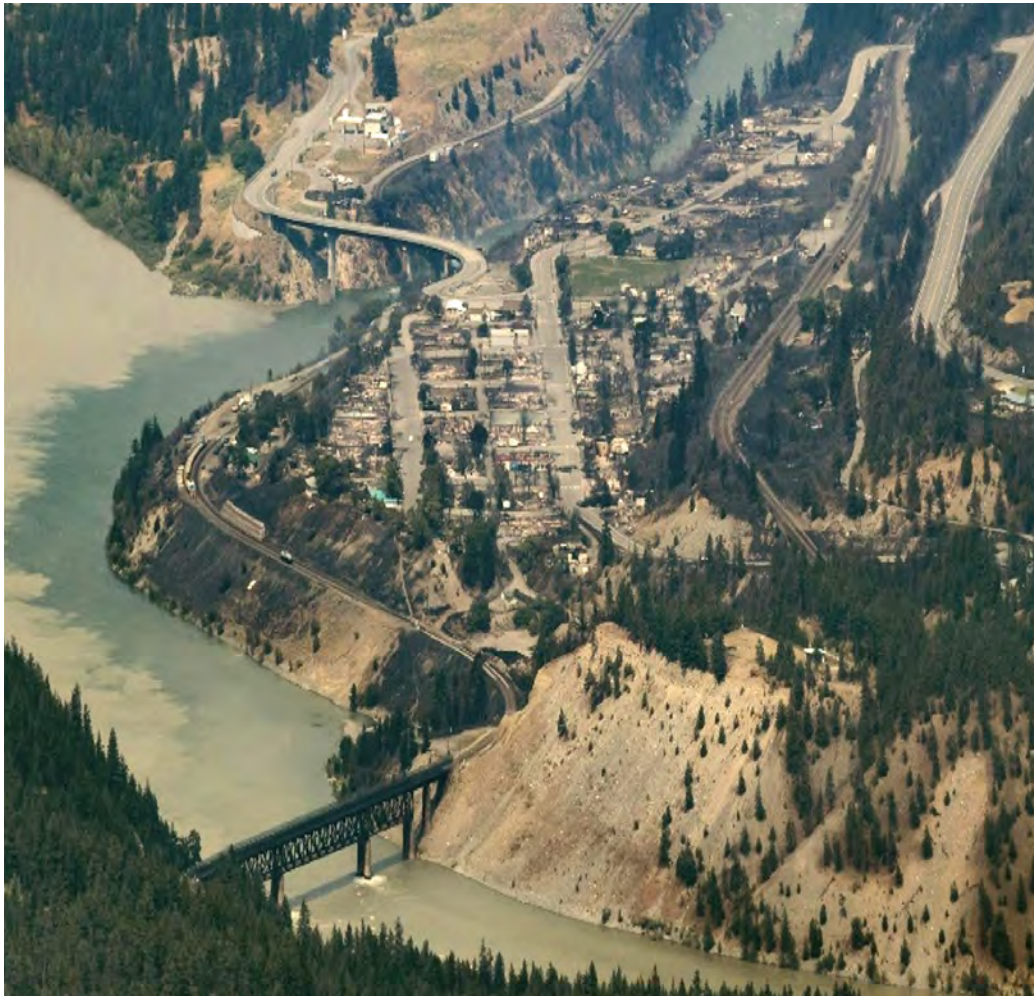
The oblique aerial photo (Fig. 2) taken shortly after the fire shows extensive amounts of unburned (green) tree and shrub canopies in the surrounding forest areas and within the community. The unconsumed canopy foliage substantiates that a high intensity crown fire did not occur; thus, could not be responsible for the resulting total fire destruction. Conversely, our on-site examination revealed nearly 100% of the surface fuel had been consumed with pervasive evidence of an intense burning ember exposure; for comparison, visualize a winter blizzard of snow pellets but the snow pellets are burning embers instead.

Figure 2: Green tree and shrub canopy foliage within the blackened areas of surface fire and adjacent to destroyed structures within the community. The photo does not include the IR 17 residential area that is off the scene to the center-right.

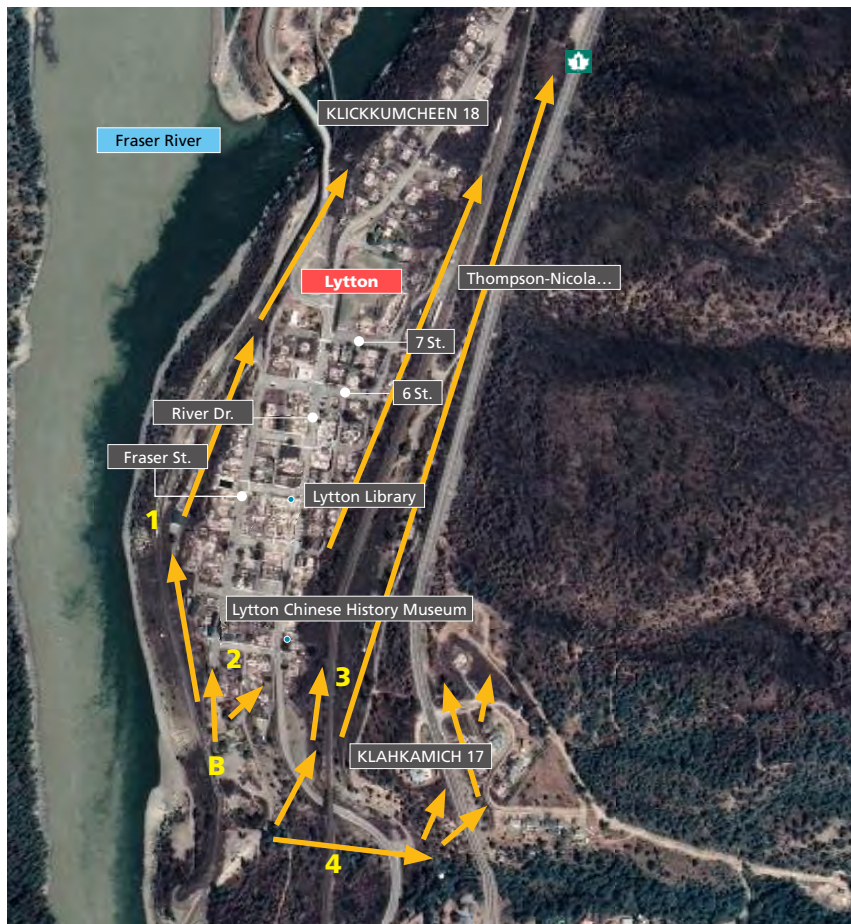
We graphically estimated the four separate principal paths of wildfire spread out of a small basin near the CNR tracks south-southwest of Lytton Village (Fig. 3). Spread along the four paths was simultaneous, but the spread rates were not necessarily equal. Figure 3 notations locate the basin (B) and Spread Paths numbered 1 to 4. Numbering of the Spread Path arrows does not imply chronological order, or an intensity ranking.

Figure 3: Arrows trace the estimated eventual Spread Paths of wildfire that exposed Lytton Village, IR 18 and IR 17 to flames and burning embers that initiated community ignitions.

- (1) Fire spreads along the steep slope above the CNR tracks on the west side of Lytton;
- (2) Fire spreads directly into the Lytton Village area south of 1 St;
- (3) Fire spreads along the east side of Lytton Village on both sides of the CPR tracks and along the west side of Trans-Canada Highway 1; and
- (4) Fire spreads up the steep forested slope across Main St and the CPR tracks to Highway 1 and across Highway 1 to the western edge of IR 17.

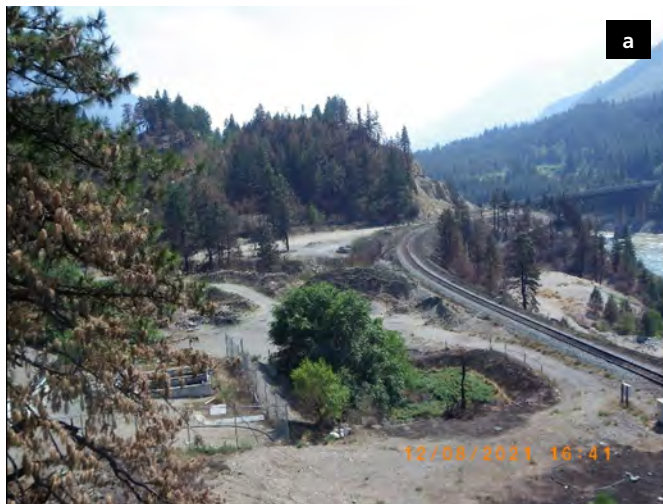
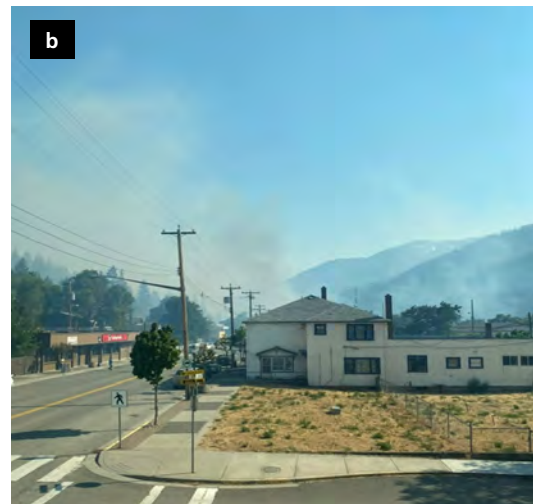
Figure 4: a) Discontinuous burned patches in the basin (B in Fig. 3) with the steep bluff in upper center of photo (left); b) Smoke rising from vicinity of the basin (B) at 1649 hours, as viewed from Main and 5 St. (Zoey Shamley)

- 1649 – Personal observation at 5 St and Main apartment of smoke with ash and ember debris carried by a strong wind (Fig. 4b).
- 1654 – Personal observation of surface fire burning rapidly upslope towards CPR tracks, homes, Old TCH and Highway 1 at rear of Main Street buildings, opposite First Street. (Fig. 7a)

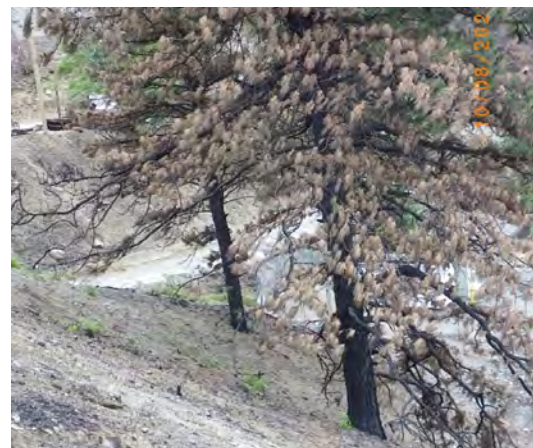
Figure 6: Spread Path 2 at the top of the basin leading into the Village of Lytton.

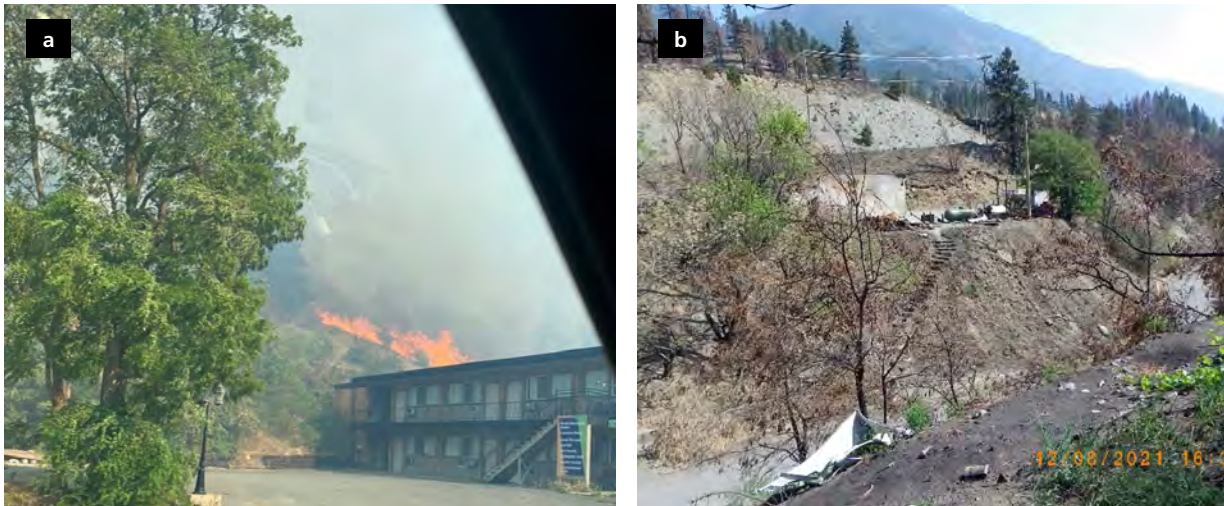
Figure 7: a) Along Spread Path 3, east of Main & Second St., the Village of Lytton, burning at 1654 hrs. (Zoey Shamley); b) Post-burn view of Spread Path 3 on the east side of the Village of Lytton extending up to IR 17.

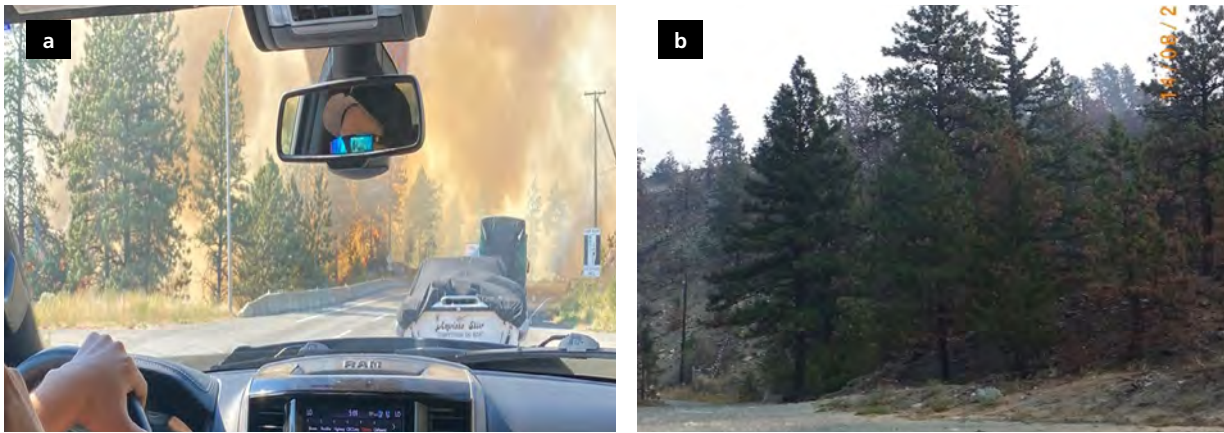
Surface wildfire spreading east along Spread Path 4 primarily spread through a continuous surface layer of loose Ponderosa pine needle and twig litter until reaching Highway 1. Fire spread would have been largely dominated by steep slopes (30 to 60 percent) as the forest canopy and terrain shielded the understory from strong winds. Path 4 fire spread was exposed to strong winds upon reaching Highway 1 and likely spotted across into grass on the west side of IR 17. All of the wildfire Spread Paths would have been characterized by a ground blizzard of flaming and glowing embers that generated numerous spot ignitions in advance of the fire front, and able to stream across fuel gaps such as roads and a railroad bed.

Figure 8: a) Wildfire along Spread Path 4 reaching Highway 1 below IR 17 at 1709 hrs. (Zoey Shamley); b) Post-burn view of Spread Path 4 leaving the basin to the east toward IR 17.

- 1716 – Personal observation from 5 St and Main apartment of structure fire in the vicinity of south Fraser St.
- 1718 – Personal observation while traveling south on Highway 1 past IR 17 that fire had crossed the highway and burning on the western side of IR 17 (Fig. 8a).

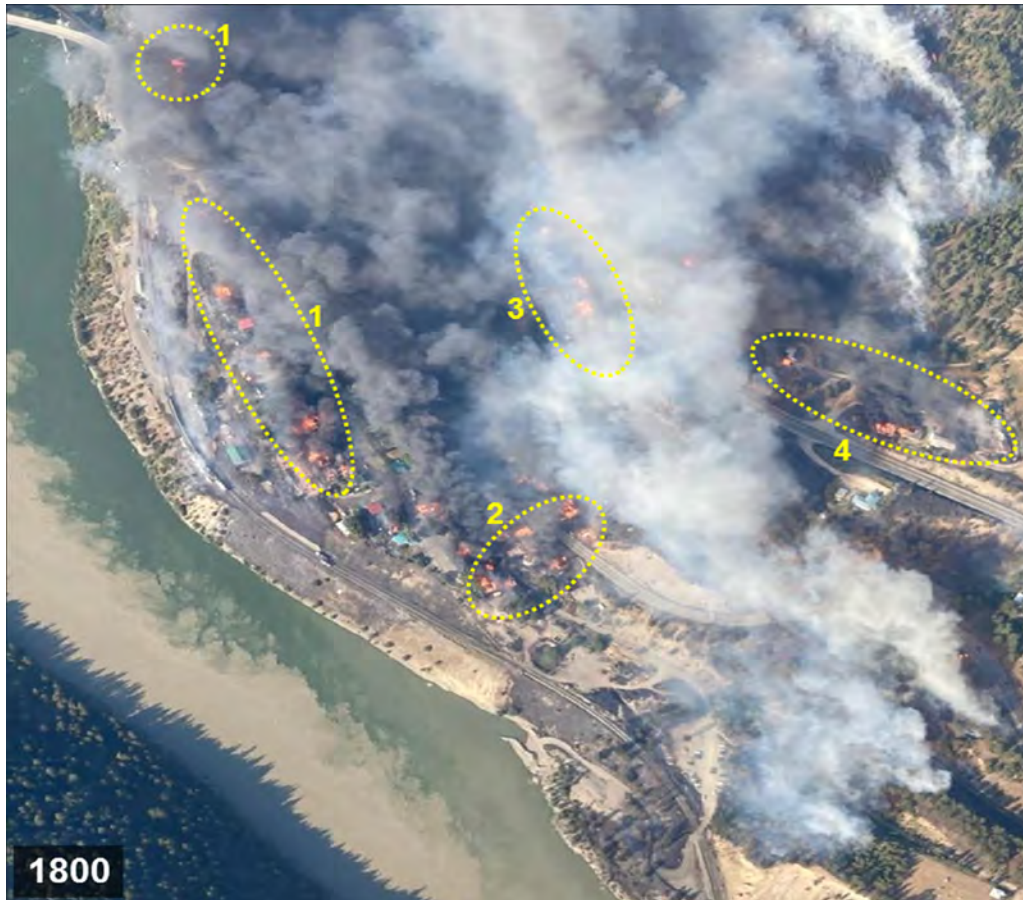
1800 photo

Figure 9: Aerial photo at time 1800 hrs. (BC Wildfire Service photo)

Less than 1.5 hours after the Lytton Fire was reported (1638 hrs), the community in this scene is burning without any active wildfire adjacent to the community. Blackened areas on the perimeter show where the wildfire has burned adjacent to the community; it has since burned out and is no longer smoking after consuming the fine fuels. As well, there is no evidence of high intensity crown fire in the green-canopied forest surrounding the community.

Burning structures along the Lytton community perimeter indicates the surface wildfire-initiated ignitions of flammable materials on private property that spread to then ignite structures. Ignitions have been initiated in IR 18 and a fully involved structure is burning (Fig.9, upper left 1 oval). Smoke is likely obscuring other structures that may be burning in IR 18. Ignitions of structures and nearby urban fuels initiated by Spread Path 2 have resulted in community fire spread with structures burning in the southern part of the Village of Lytton (2 oval). Similarly, Spread Path 3 initiated home ignitions along the old Trans-Canada Highway and has resulted in several homes burning (3 oval). Homes and sheds are burning in IR 17 initiated from Spread Path 4 (4 oval). Over 20 primary structures are burning.

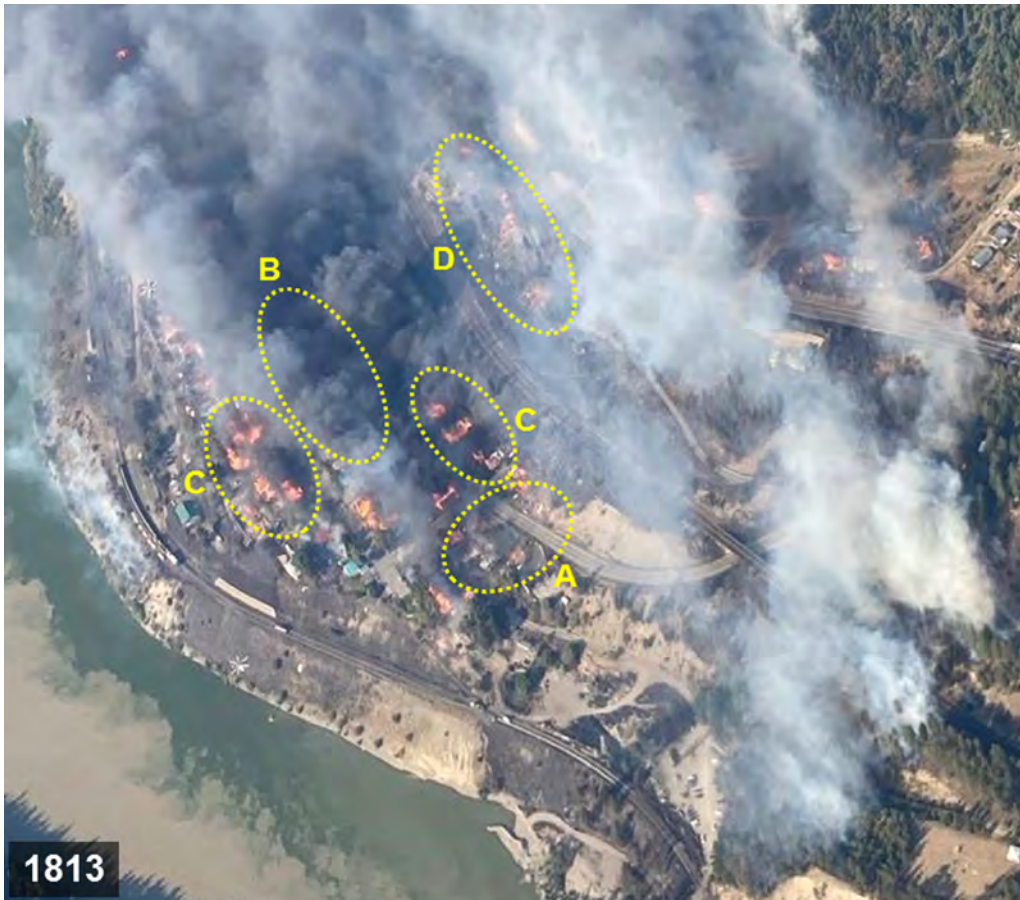
1813 Photo

Figure 10: Aerial photo at time 1813 hrs. (BC Wildfire Service photo)

Thirteen minutes later most of the structures south of 1 St are completing consumption (**A** oval). Just to the west, structures between Fraser St and River Dr continue to burn vigorously. Although smoke obscured, the Village of Lytton north of 2 St between Fraser and Main St (**B** oval) does not show significant fire involvement. However, the contiguous fire involvement west of Fraser St and east of Main St north of 2 is becoming increasingly fire involved indicating structure-to-structure fire spread (**C** ovals). For example, the buildings of and around the Totem Motel on the west side of Fraser St between 2 and 3 St have become more involved, and just north of there, the Catholic Church and the front of the pool building and Chamber of Commerce appear to be burning. The homes burning along Spread Path 3 (Fig. 3) are now in the final stage of consumption (**D** oval).

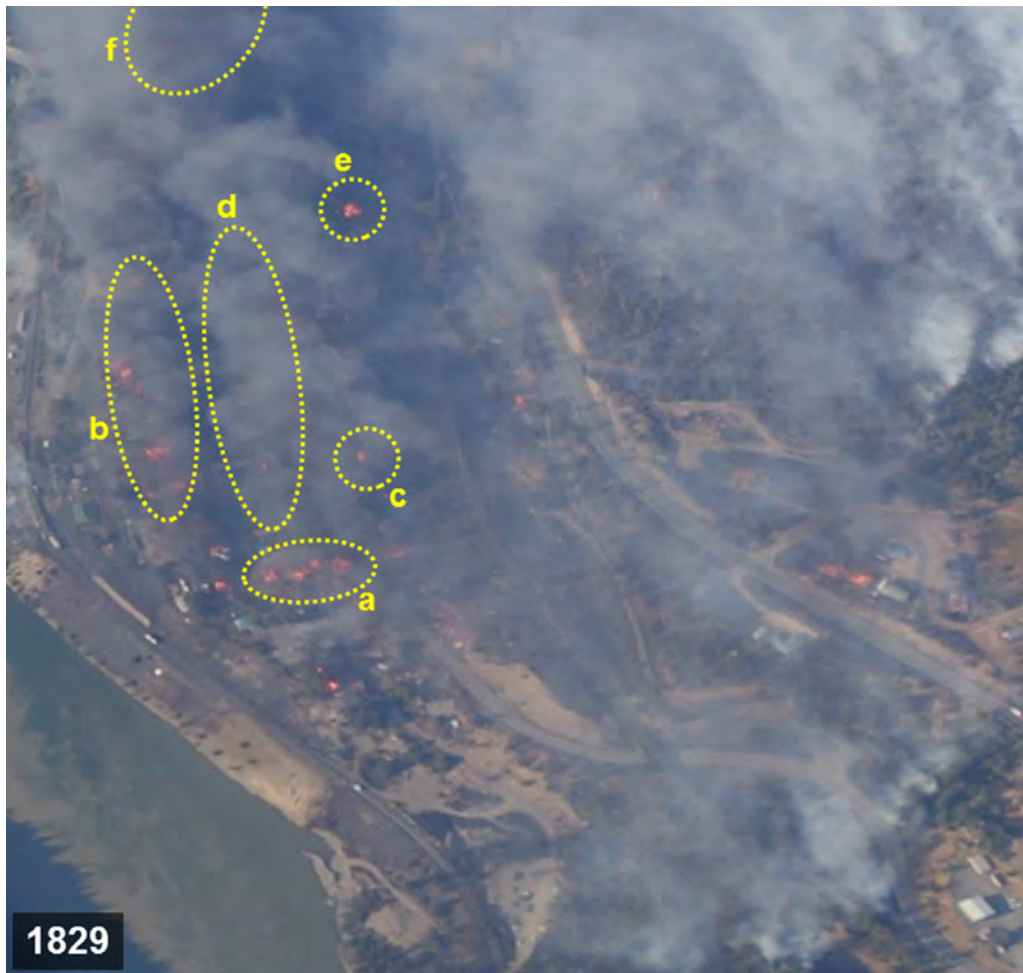
1829 photo

Figure 11: Aerial photo at time 1829 hrs. (BC Wildfire Service photo)

In the 16 minutes since the last scene, all the structures on the south side of 2 St from the west side of Fraser St to the east side of Main St are burning (**a** oval). Most of the structures burning south of there have largely been consumed. Structures on the west side of Fraser St continue to burn (**b** oval). Compared to Figure 10, it appears the Totem Motel structures have largely been consumed with the Catholic Church in the last stages of consumption (southern portion of **b** oval). Fire has advanced north on the east side of Main at 3 St (**c** oval). The Village of Lytton north of 2 St between Fraser St and Main St has yet to start significantly burning (**d** oval). A structure on the east side of Station St and 7 St is fully involved (**e** oval). Although obscured by smoke and not evident in the above Figure 11, the original photo reveals “glows” of flame indicating a number of involved structures in IR 18 (**f** oval).

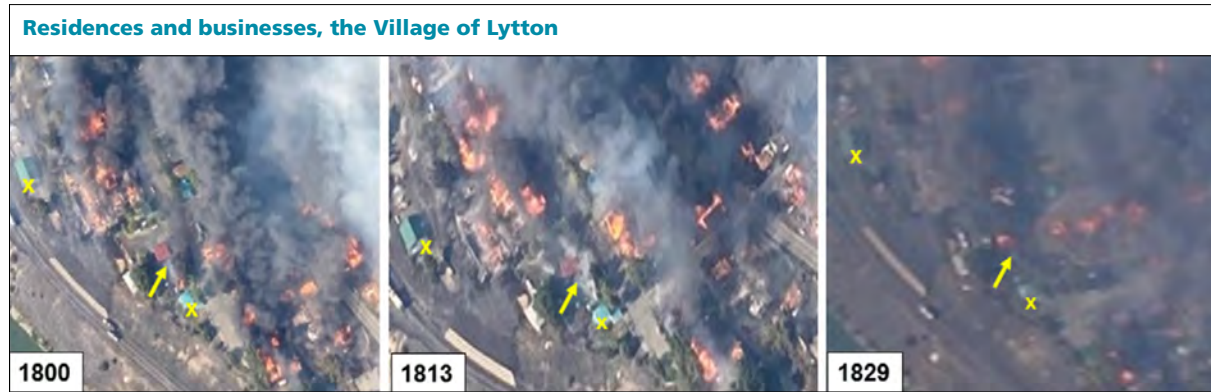
Figure 12: South Lytton Village at 1800h, 1813h, and 1829h. Photos are referenced to one another by a yellow x on two different buildings with turquoise-colored roofs. Yellow arrow locates the surviving home of interest.

1800 – The yellow arrow identifies the house that did not burn. The neighboring house to the south is burning; the house on the north side (red roof) is not. Across Fraser St. from the surviving house is a structure becoming fully fire involved.

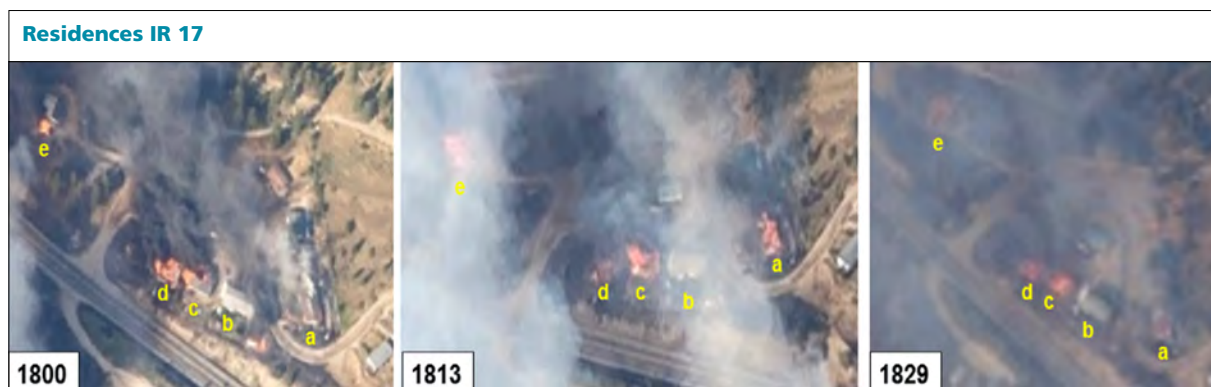
Figure 13: Time progression of 5 destroyed houses in IR 17. Each photo references the houses with yellow letters a – e.

1800 – Each of the five residential lots, **a – e**, have structures burning but only 3 homes are involved at 1800. The two homes not yet involved, **b** and **e**, both have sheds burning. The burning house, **d**, is fully involved suggesting it was the first to have significant structure flame spread. The house next door to the south, **c**, is heavily involved on the side adjacent to the burning house suggesting a structure-to-structure thermal influence. House **a** is smoking but does not show significant exterior flaming.

1813 – The initial burning home, **d**, has collapsed to a burning debris pile and the adjacent house to the south, **c**, is now heavily involved. The house, **a**, that had been smoking at 1800 is now fully involved. The house to the north, **e**, with the shed burning, is now fully involved. The other house, **b**, with a burning shed does not show signs of significant fire involvement.

Closer analysis of burning homes in IR 17 provides more detail of how the homes ignited and burned than is apparent from a post-fire examination. The ignitions in IR 17 resulted from Spread Path 4 (Fig. 3), to the east and above the Trans-Canada Highway. Specifically, a “ground blizzard” of burning embers streaming across Highway 1 ignited surface fires, largely in dead grass, along the western edge of IR 17. Surface fire and ember deposition in cured grass and leaf litter most likely initiated ignitions on residential property that spread in vegetation, sheds and debris to ignite the five destroyed homes.

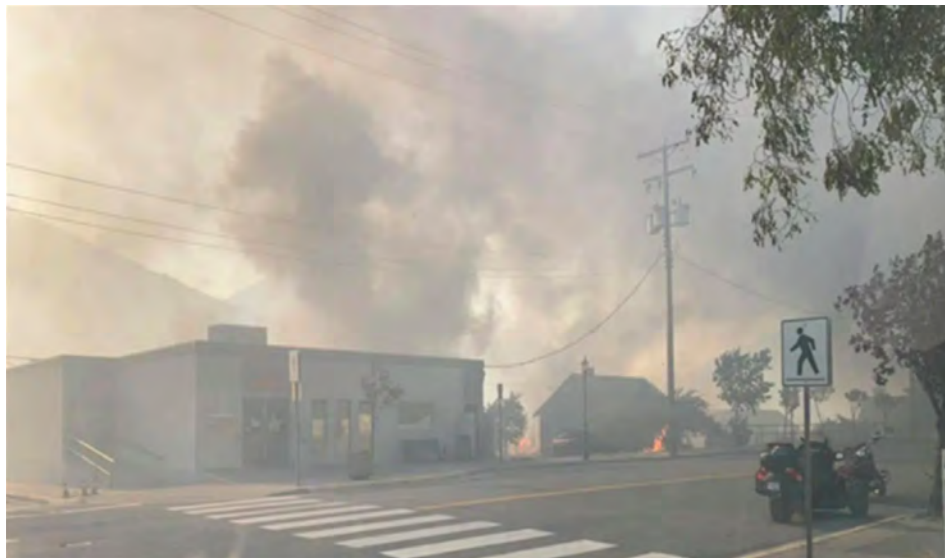
The following photo (Fig. 14), taken in a northwesterly direction at 1830 hrs, shows the Post Office (left) and two homes (right) that have ignited and are beginning to burn. Contiguous fire spread could not occur due to fuel gaps from streets and discontinuous fuels commonly between structures; thus, burning embers became the primary ignition source. This produced the structure “spot fire” ignition pattern of structures downwind of other burning structures. Except for the Post Office, all the primary structures bounded by Main and Fraser St, and 6 and 7 St were totally destroyed from ember-initiated ignitions.

Figure 14: Structure ignitions from burning embers in the Village of Lytton, at Main St and 6 at 1830 hrs. Smoke obscured this area in the 1829 hrs photo (Fig. 11) preventing a photo determination of the initial burning in the north Village of Lytton that is provided by this photo.

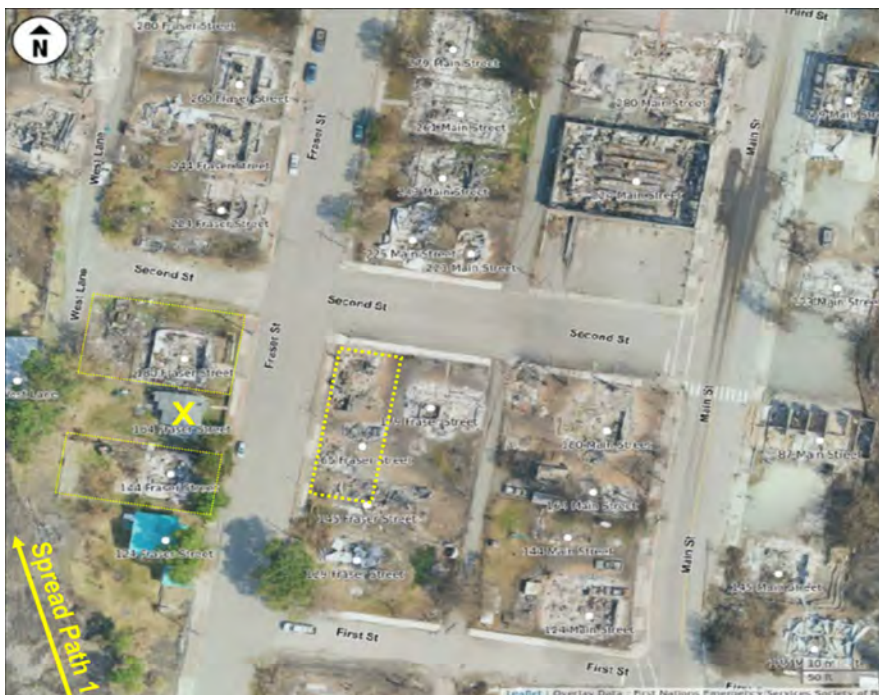
Figure 17: Post-fire Lytton Village scene between 1 and 3 Streets on July 12. The yellow X identifies the surviving house identified by a yellow arrow in Figure 14 (First Nations Emergency Services Society of BC).

This post-fire view of a southern area of the Village of Lytton shows the overlapping HIZs typical of the community (Fig. 17). With the exception of the small lower left area identified as Spread Path 1, this scene had no wildland fuel. Surface fire in short, dry turf grass within the HIZs was likely initiated by embers and continuous low intensity surface fire from wildfire behind the two houses (dark area burn marks at lower left) south of the surviving house (yellow X). The house south of the surviving house (dashed yellow rectangle, Fig. 17) was burning at 1800 and largely consumed by 1813 (Figs. 9 and 10).

Figures 9 – 11 above generally revealed the Village of Lytton structure fire involvement and progression during the brief period from 1800 to 1829 hrs. Closer examination of events within shared HIZs and between HIZs reveals more about the evolving disaster.

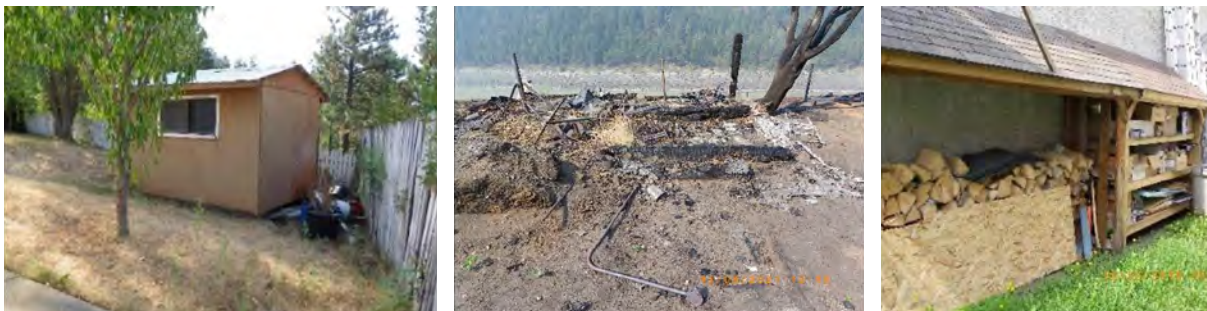
Figure 18: Outbuildings such as the shed on the left are ignition vulnerable from fire spreading in dead grass, flammable debris or a wood fence to contact and ignite it or directly ignite from burning embers such as the firewood on the right. Once ignited, the burning outbuilding or adjacent firewood ignites the house or business.

Key Finding (7): Fire spread continued through the Lytton Community was principally determined by the highly vulnerable ignition conditions within individual HIZs, and by high structure-to-structure flame spread potential due to overlapping HIZs. Density of structures in Lytton-area communities was commonly increased by placement of highly ignitable sheds, workshops and other flammable materials close to primary structures.

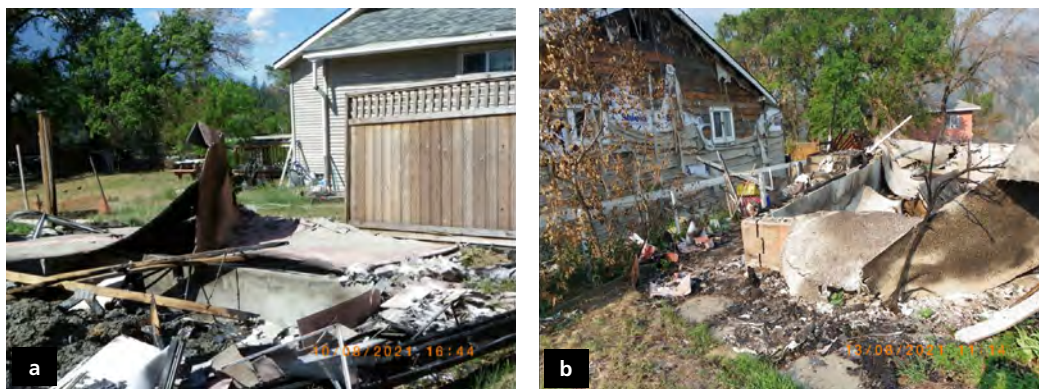
Figure 19: a, b) Adjacent burned houses to the south (left) and north (right) have non-flammable stucco exterior walls.

The south side burning house (Fig. 19a) did not thermally damage the surviving house (about 9 m separation), and there was no char on the wood fence panel (about 2 m separation). The north side burning house (Fig. 19b) was much closer (about 3m) to the surviving house. The top rail of the low wire fence was not charred, and the PVC vinyl siding had little thermal damage within 1 m of the ground. The thermal damage to the surviving house was likely radiation from the burning roof and attachments. As can be seen in Figure 19b, the vinyl siding melted off a portion of the exterior wall wood board sub-sheathing and eave enclosures. None of the exposed wood board sub-sheathing was significantly charred. The plate glass windows fractured but the small glass panes remained held in the vinyl sashes. For perspective, PVC softens to produce damage starting at 95 –100°C; PVC liquefies starting at 180°C; and PVC begins to decompose to produce flammable vapors starting at 140°C. In contrast, wood surface temperature associated with flame ignition is about 325°C. Thus, melted PVC siding is not indicative of the potential for wood wall ignition.

Key Finding (8): *The non-flammable exterior walls remaining until structure collapse prevented flame radiation and contact sufficient for ignition at the adjacent surviving house. This indicates an opportunity to use common building materials that mitigate structure-to-structure community fire spread where there are densely overlapping HIZs.*

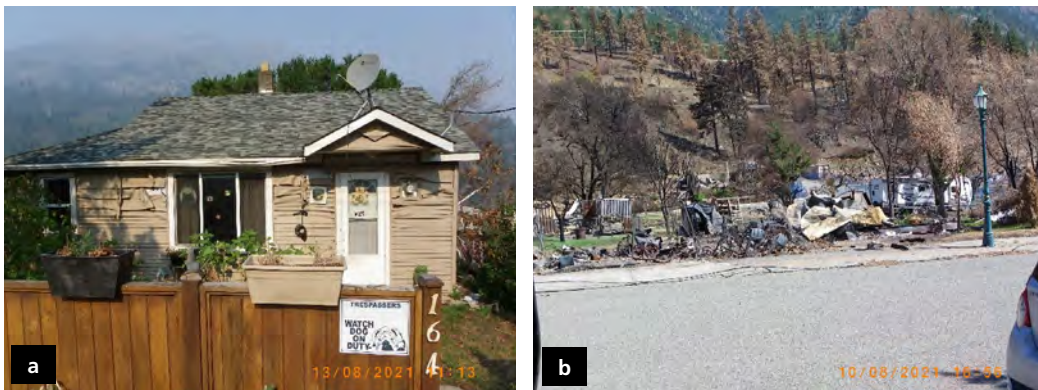
Figure 20a: Thermally softened vinyl siding on the upper third of the front facing burning structures across Fraser St. Note the wood fencing closer to the thermal source without char. Figure 20b: Burned structures across Fraser St. produced the thermal radiation that damaged the vinyl. These structures are identified in the coarse dashed yellow rectangle of Figure 17.

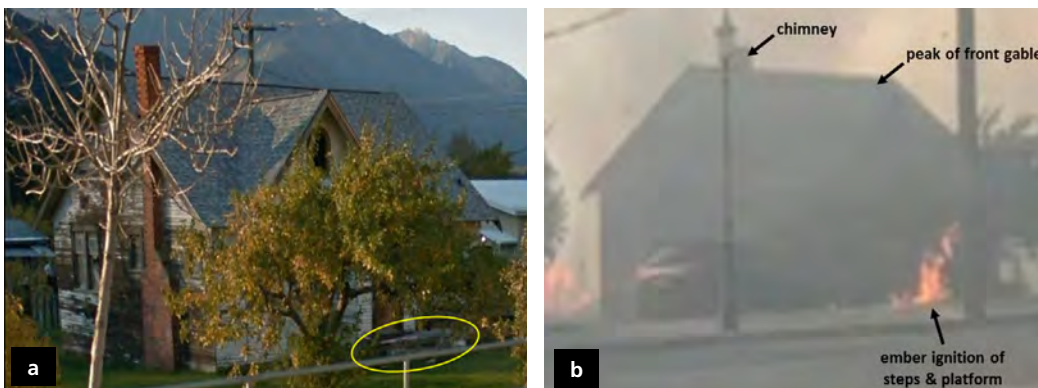
Radiant heating across streets (10 m or more) from burning structures was insufficient to, and did not, initiate ignitions in adjacent blocks. If not flames, then burning embers principally from burning structures must have produced the ignitions from block to block resulting in the Village of Lytton fire spreading across streets. Key Findings (5) and (6) are consistent with observations from other WU fire studies (Cohen and Stratton 2008; Cohen 2010; Calkin et al. 2014) and with the science that developed the HIZ (Cohen 2004). Figure 21 provides an example of this typical mechanism of fire

Figure 21: Burning embers ignited the ignition vulnerable wood steps and decking at the front entry way (a) of the house (a, yellow oval). Another ember ignited structure (b) is in the background to the left of the house in front. This house is also shown to the right of the Post Office in Figure 14.

spread, wherein burning embers were likely generated by burning structures in the adjacent upwind block, and windblown to the house in the photo. The paired images of before (left, October 2018) and during (right, 1830 hrs) the Lytton WU fire illustrates the principal vulnerability that likely contributed to the ignition. The highly weathered wood with openings beneath and between members of the wooden stairs and landing would have accumulated leaves and other combustible debris in addition to the inside corners of the stair/landing construction where burning embers commonly accumulate during extreme wildfire conditions.
