# Vulnerability of Vents to Wind-Blown Embers

AUGUST 2017

Stephen L. Quarles, Ph.D.

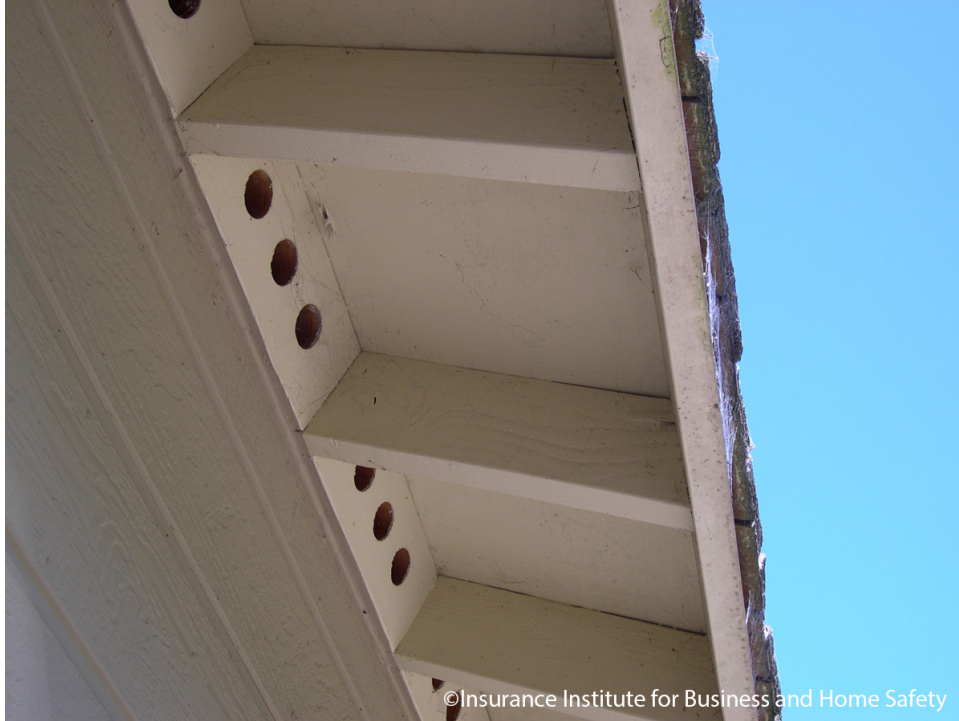
**Figure 1.** Vents located in between-rafter blocking in the under-eave area of a building that used open-eave construction.

Two types of under-eave (inlet air) vents were used. These included (1) open-eave vents that are incorporated into the solid-wood blocking inserted between roof rafters (or trusses), and (2) vents that are incorporated into the soffit material in “boxed-in” construction, as shown in Figures 1 and 2, respectively. A standard overhang width of 18 in. (460 mm) was used on all sides of the test building. An interior attic partition was constructed to separate the two inlet vent sections of the test building (i.e., the open-eave and soffit-eave sections) used for these experiments (Figure 3).

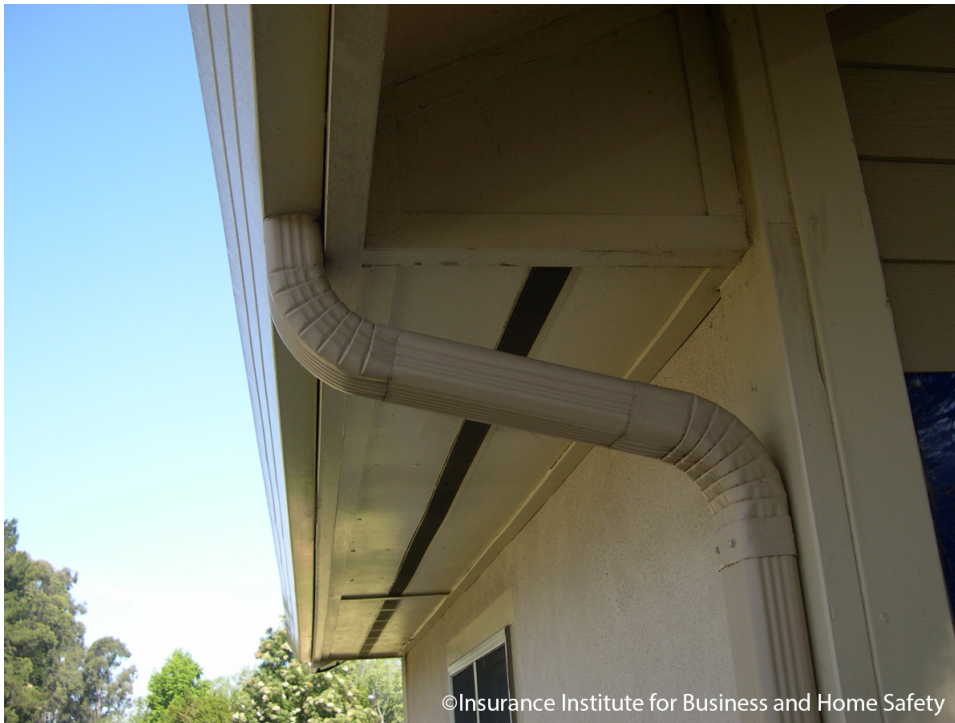
**Figure 2.** A strip vent located in the soffit of a building that used soffited-eave construction.

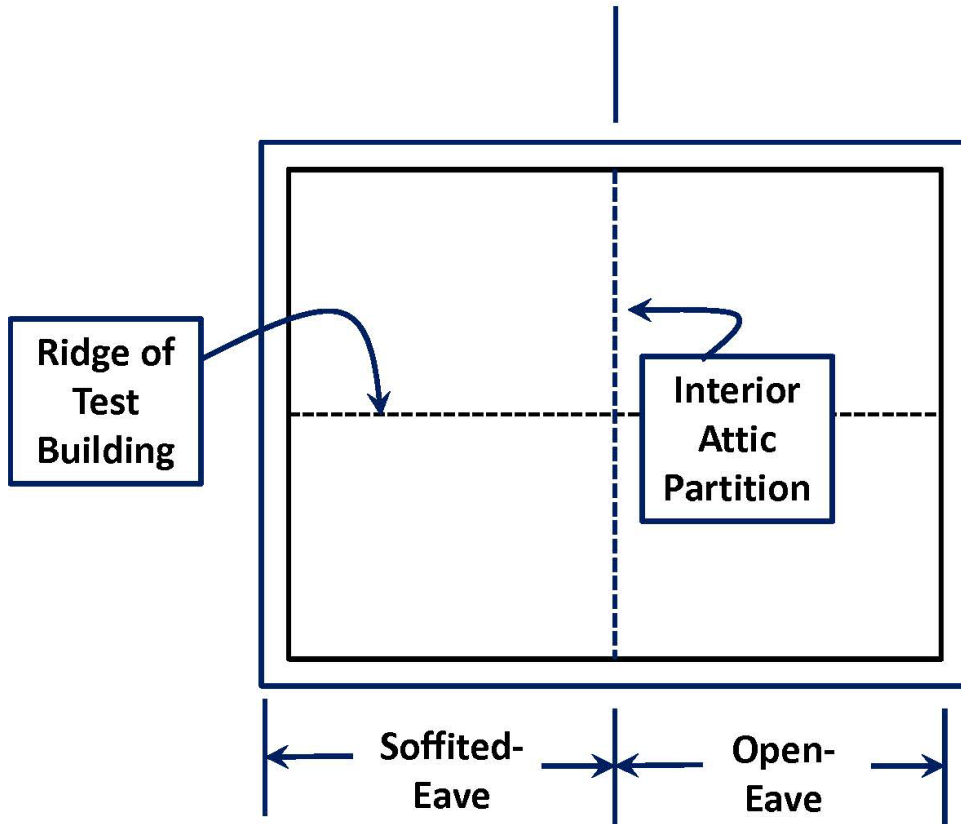
**Figure 3.** A plan view diagram of the test building showing the location of the two types of inlet (under-eave) vents used in this series of experiments.

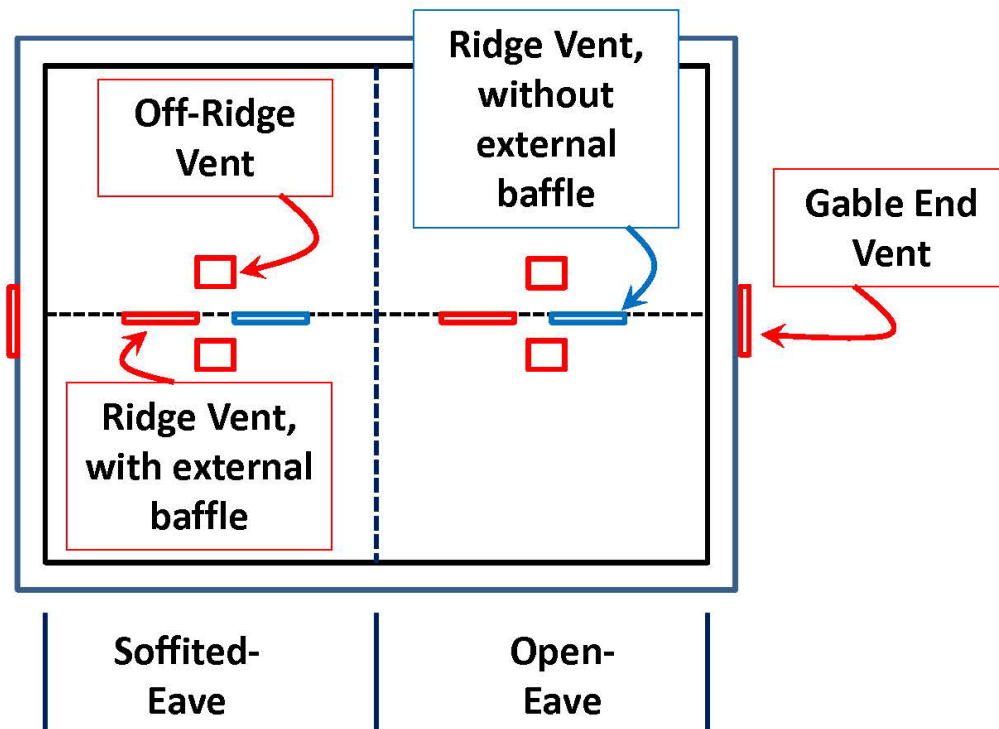
**Figure 5.** Locations of gable end, ridge, and off-ridge vents. Only one of these vent types was installed during a given experimental series.

A diagram showing the locations of the outlet vents is given in Figure 5. As indicated, only one outlet vent was used during any individual test.

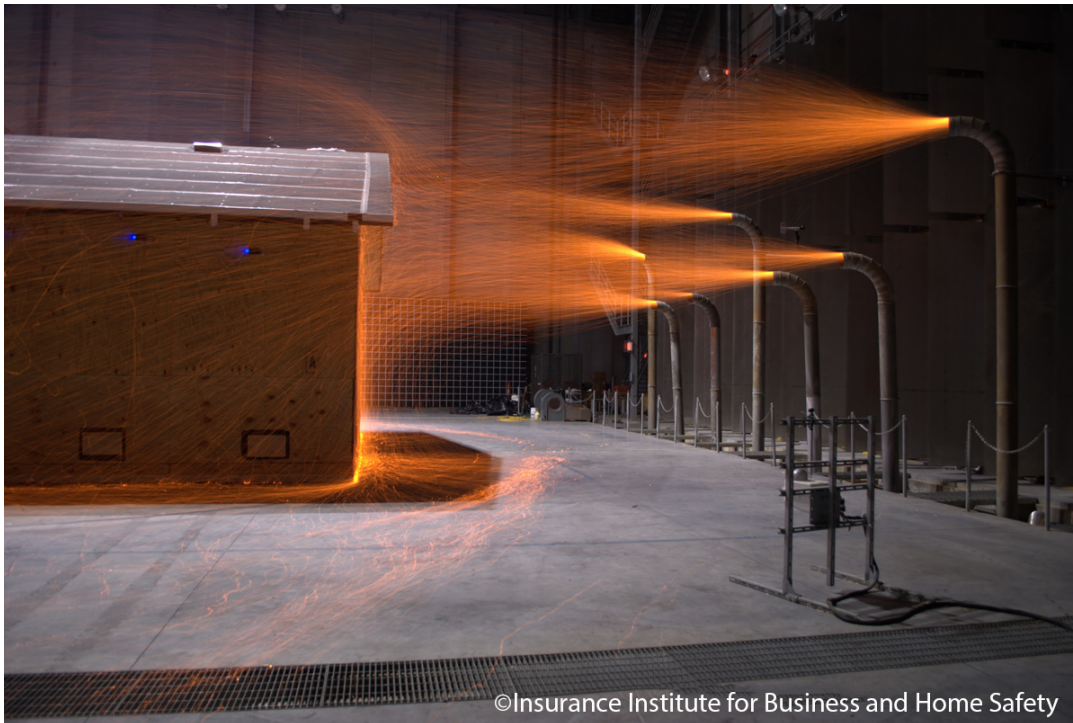
**Figure 10.** Ember generators operating during a test.

All seven ember generators were run during each test. A representative photograph of these generators is shown in Figure 10.

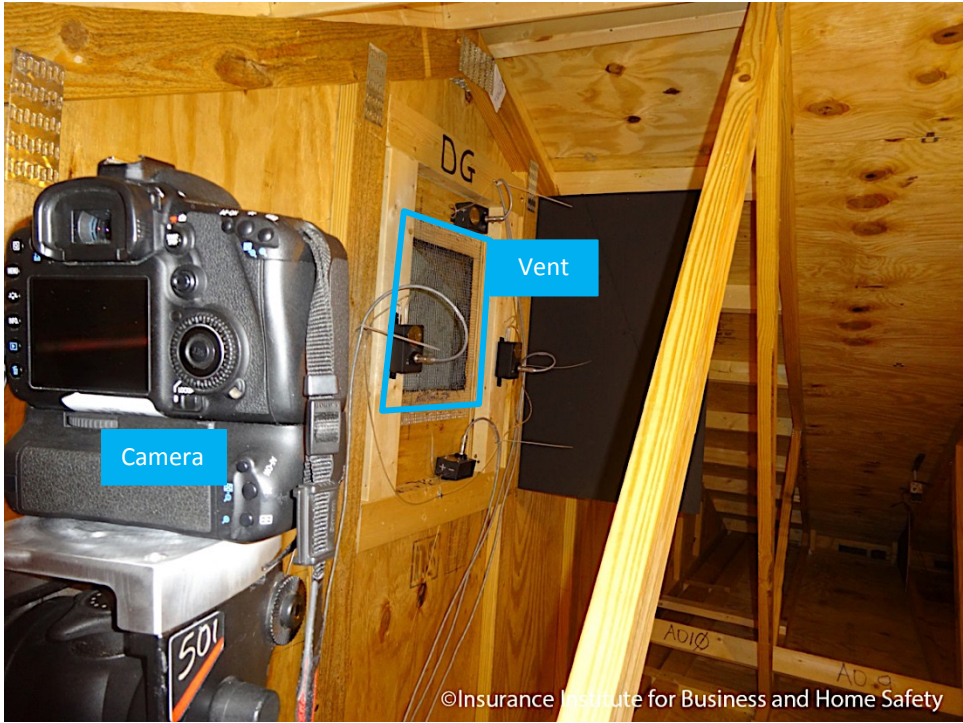
**Figure 11.** Typical video camera setup used to evaluate ember entry through the gable end vent.

Video- and non-video-based measurements were used to evaluate the ability of a given vent to resist the intrusion of wind-blown embers. For each test, cameras were positioned at interior location(s) to capture video of embers that entered through one or more vent openings. In the case of inlet (under-eave) vents, the field of view of a given video camera was sufficient to capture entry through two or three vent openings. For gable end and through-roof vents, cameras were only able to capture ember entry for an individual vent. A post-processing procedure using a particle tracking algorithm was used to count embers. Typical camera setups are shown in Figures 11 and 12.

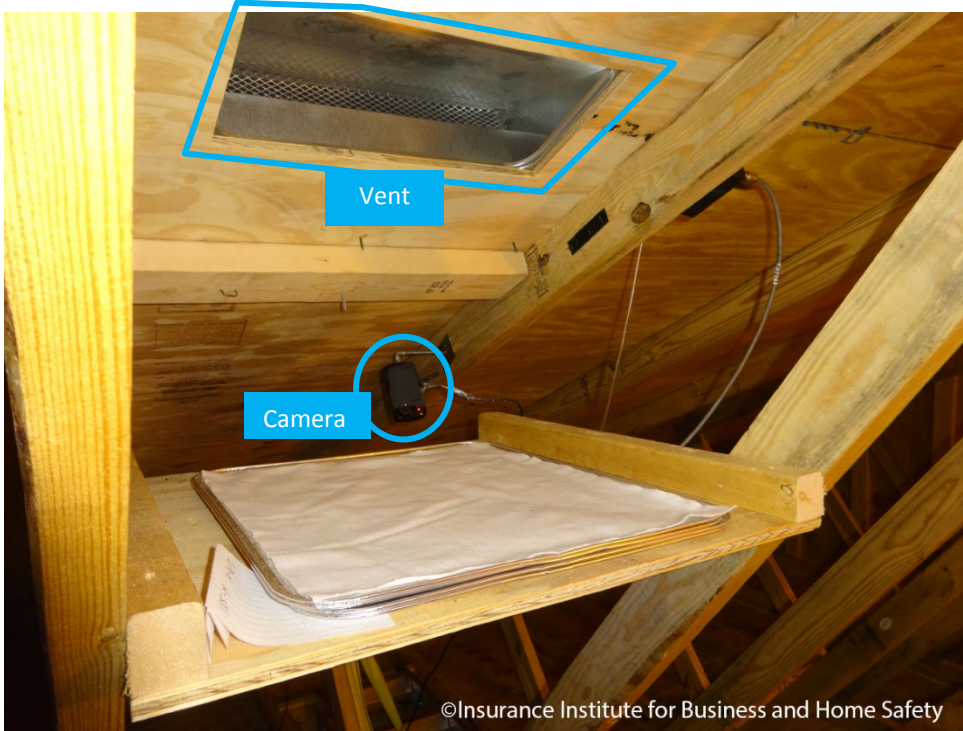
**Figure 12.** Typical video camera setup used to evaluate ember entry into a through-roof vent.

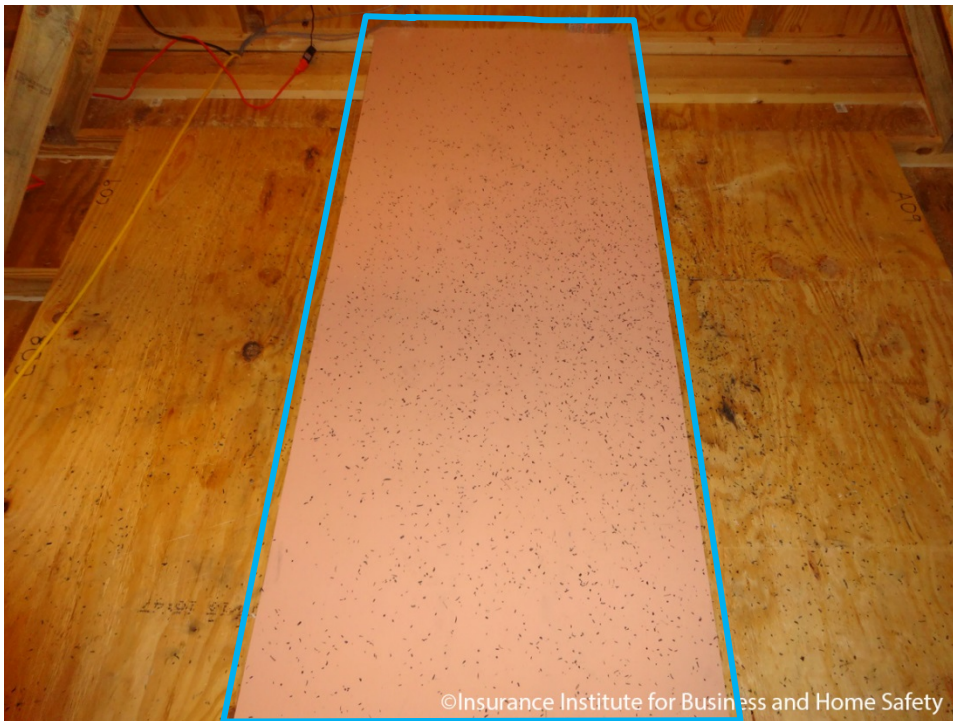
**Figure 13.** Embers that landed on the 3 ft by 8 ft (0.9 m x 2.4 m) panel (blocked in blue) were collected and weighed after each test. This technique provided means to quantify ember entry through the gable end vent. Note that embers (the black particles) landed on and off the panel. Only embers that landed and accumulated on the panel were weighed.

During the gable end vent tests, a 3 ft x 8 ft (0.9 m x 2.4 m) section of a wood-based panel was placed below the inlet of the vent (Figure 13). After each test, the embers that landed on the panel were collected and weighed.

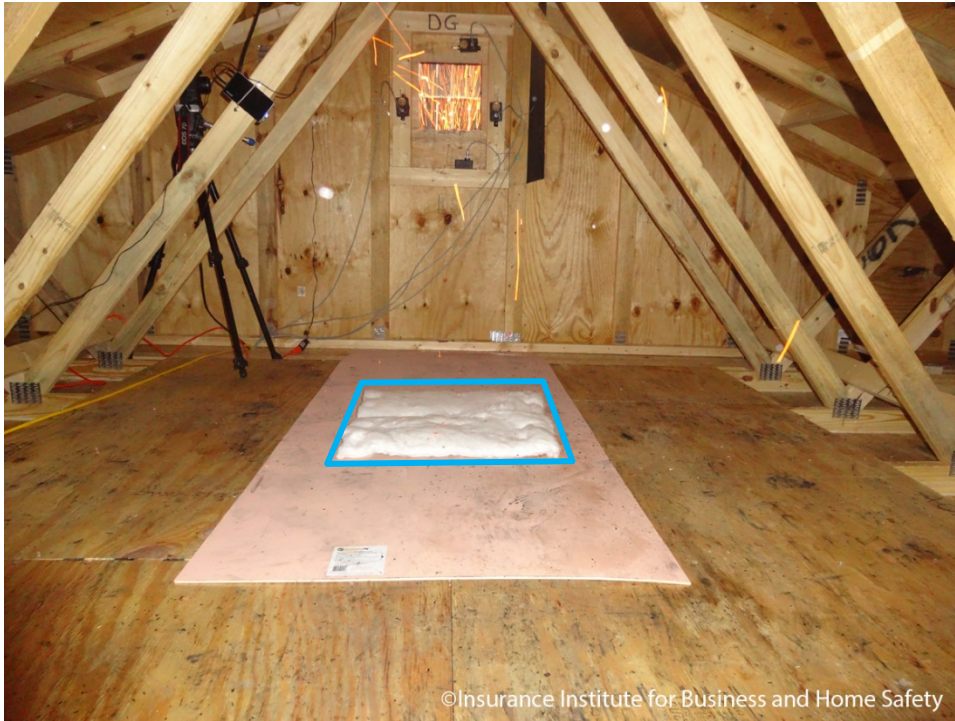
**Figure 14.** A cotton pad was placed on a horizontal surface, near the entrance of gable end and all through-roof vents to evaluate the ability of entering embers to ignite a combustible material.

During gable end and through-roof vents tests, a cotton pad was placed on a horizontal surface near (under) the entry area for the vent. In the case of the gable end vent, the cotton was placed on the panel previously mentioned (Figure 14). In the case of other through-roof vents, the cotton was placed on an elevated platform (Figure 12). The cotton was used to evaluate the ability of embers to ignite fine fuels in an attic space. Cotton served as a surrogate for all combustible fine fuels that could be in an attic space. Cotton was selected because it was the combustible materials selected for use in the ASTM standard test method to evaluate the performance of vents (ASTM E2886). Cotton is also used in other ASTM fire test standards. This standard evaluates vent performance by evaluating the ability of embers that pass through a given vent to ignite the cotton substrate.

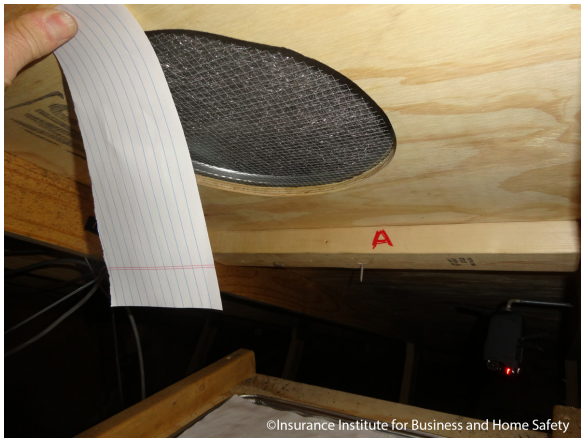
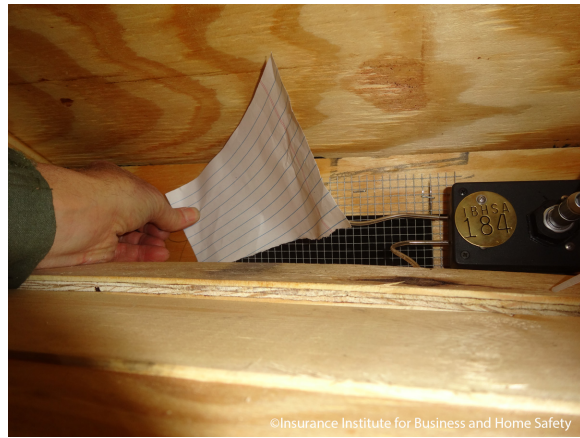
**Figure 15.** As indicated by the action of the ribbons, on the windward side of the building, the off-ridge through-roof vent (left) and open-eave vent (right) were inlet vents.

Vents are designated “inlet” or “outlet” vents based on air flow into and out of the attic space under natural convection conditions. Under the elevated wind speed scenarios used in this tests (and typically present during wildfires), all under-eave and the non-turbine off-ridge vents on the windward side of the building were inlet vents (Figure 15), and those on the leeward side of the building were outlet vents (Figure 16), regardless of their nominal designation. The ridge (Miami-Dade-compliant and non-Miami-Dade-complaint) and turbine vents were consistently outlet vents (Figure 17).

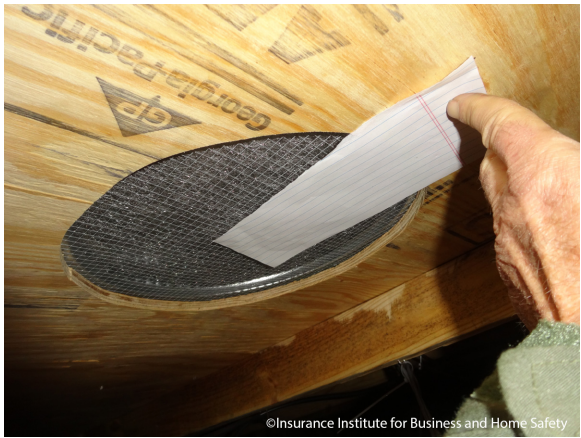
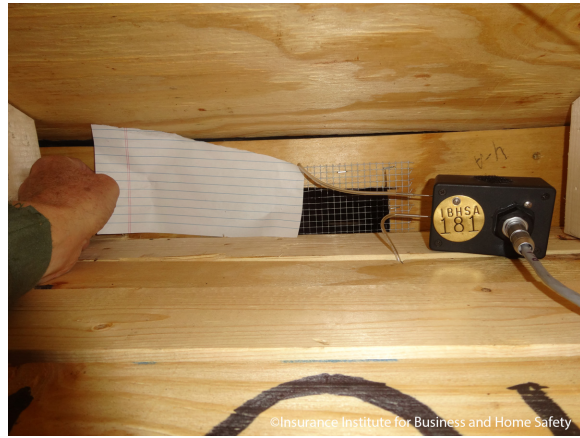
**Figure 16.** As indicated by the action of the ribbons, on the leeward side of the building, the off-ridge through-roof vent (left) and open-eave vent (right) were outlet vents.

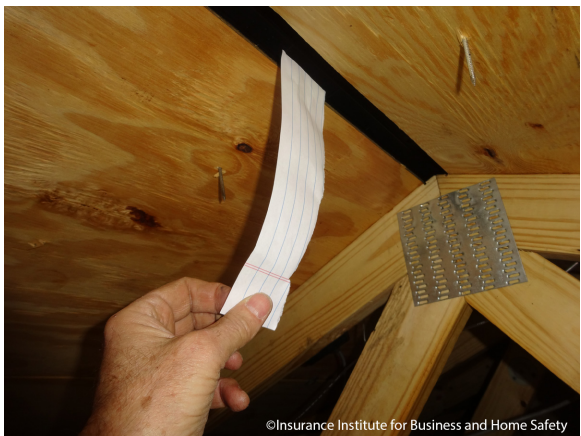
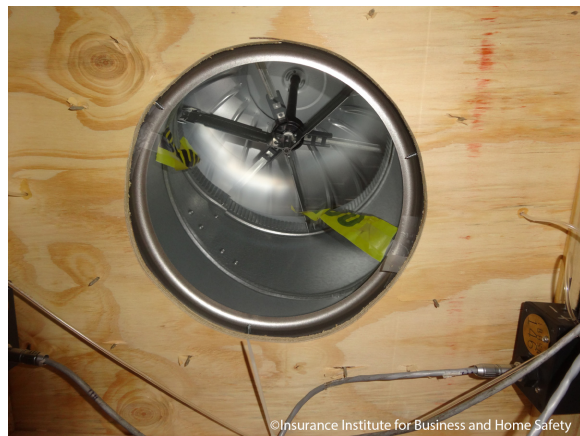
**Figure 17.** As indicated by the action of the ribbons, the ridge vent (left) and turbine vent (right) were consistently outlet vents.

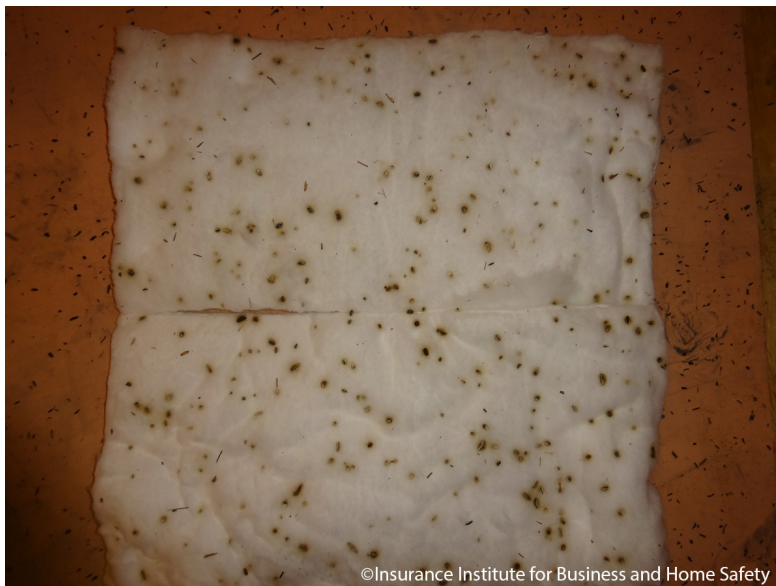
**Figure 19.** A cotton pad positioned on the attic floor at the base of a gable end vent showing numerous ember strikes. The cotton exhibited short-term smoldering combustion, but always self-extinguished without transitioning to flaming combustion.

As previously indicated, a cotton pad was used during these experiments to evaluate the ability of entering embers to ignite an easily combustible material. The cotton pads were dried in an oven with a temperature set point of 212°F (100°C) for 24 hours prior to the test. Although the ember strikes were often sufficient to result in short-term smoldering combustion of cotton pads, particularly with the coarser mesh screens in the gable end vents, in no case did combustion transition to flaming. A cotton pad after a gable end test with  $\frac{1}{4}$ -in. (6 mm) mesh screening is shown in Figure 19.
